## RESERVOIR DESIGN - 'Look, Listen and Feel'

Reservoir Design for the Future Generation

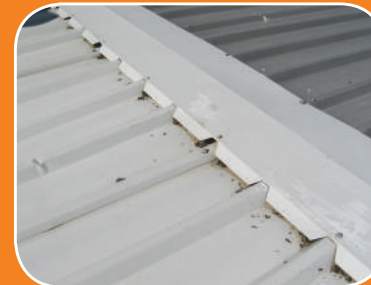
Ridge capping appears to be sealed.

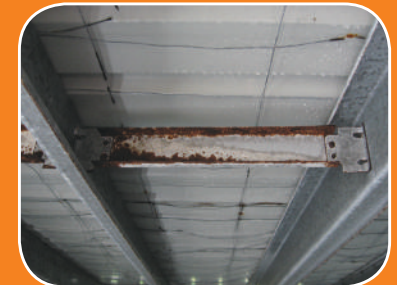
1. **Roof material failures** – metal products such as lower quality roofing screws, zincalume type rolled purlins and 'safety mesh' placed under steel roof sheets are showing serious failures in under 10 years. Most reputable manufacturers have provided good information of product suitability, yet this appears to have been ignored in many cases.

Corroded purlins and safety mesh.

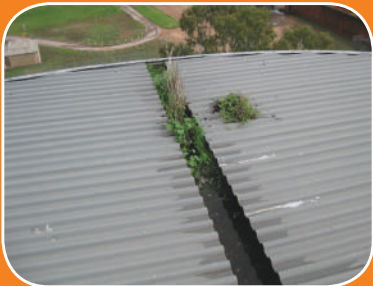
2. **Roof drainage systems** incorporating centre box gutters have a proven failure rate due to collapse and leakage issues, but they are now returning due to 'cut and paste' designing from older projects.

Box gutter blocked and overflowing.

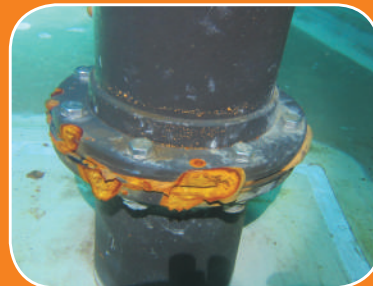
4. **Internal pipe work** that corrodes prematurely due to poor material selection or configurations that disturb sediments or make tank cleaning difficult.

New ductile iron pipework corroding.

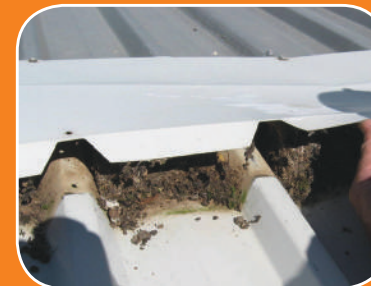
3. **The older 'centre pitched' roofing designs** are more expensive to construct and the numerous ridge flashings allow contaminants to accumulate and enter the tank. A roof utilizing full length sheets, combined with a lower pitch angle is better sealed and will allow maintenance tasks to be carried out in a safer manner.

Ridge capping debris.

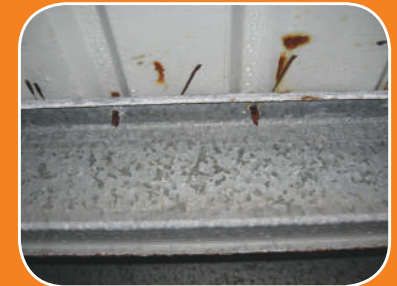
Corroded roof screws and safety mesh.

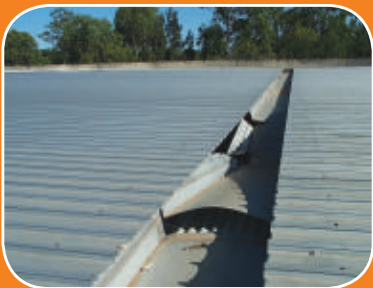
Box gutter collapsed.

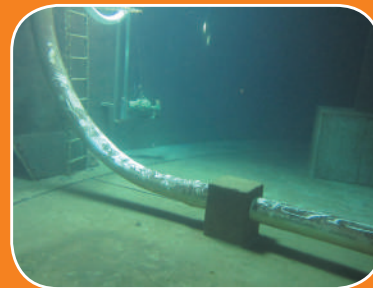
Pipe work should be under the floor.

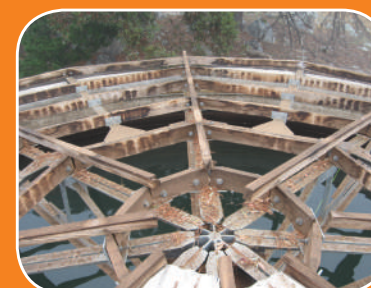
Centre pitched roof debris.

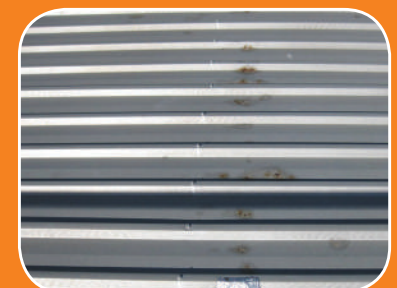
Roof sheet corrosion from safety mesh below.
