issue **9**

In the Field  
Special Edition

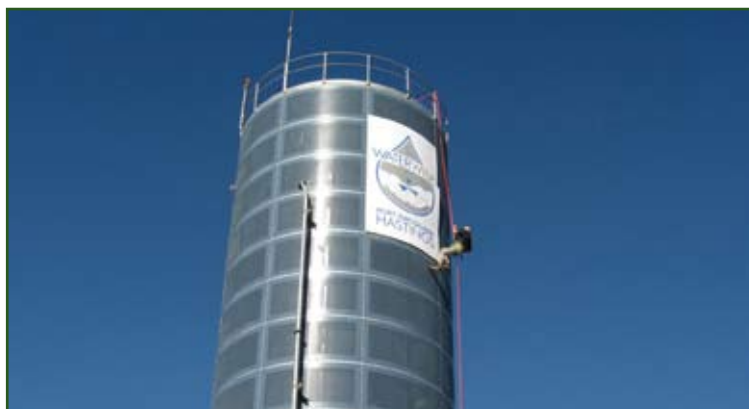
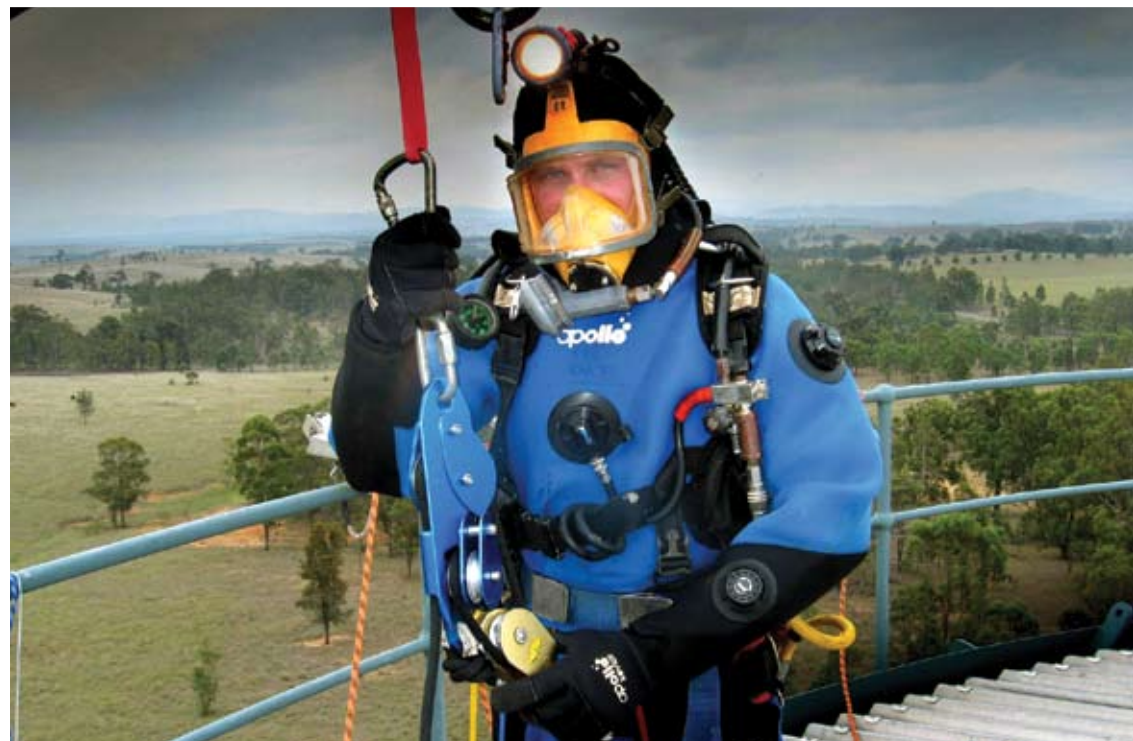
The 'waterwise' sign attached to a lime silo at Wauchope WTP had come loose on one corner, and the options for re-attaching it were limited - a large crane and man basket ...or some divers who were 'working close by'.

The Waterwise sign was a good opportunity to change over from diving to abseiling for an hour or so. The silo roof area offered good solid anchor points for the ropes and an operator was quickly 'over the side' and assessing the problem - a threaded stud that had worked loose and fallen out. A new stud was made up and then screwed in to securely attach the sign again - the remaining studs were also re-tightened at the same time to avoid any future failure from occurring.

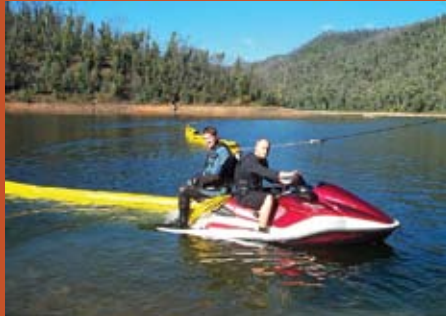
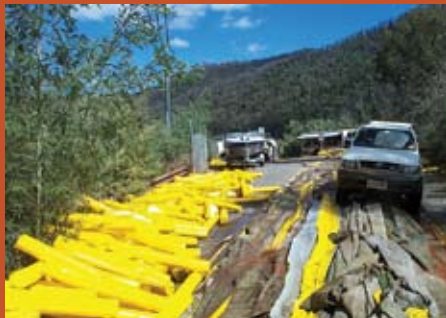
The boom material was breaking down and posing a threat to down stream pumps and pipe work. The booms were scattered along all the tributaries and inlets into the dams, often in shallow water and up to five kilometres from the base camp areas. In addition to our normal work boats, two Honda jet skis were used to support the divers and to 'power' a purpose built diving and harvesting barge. The jet skis could operate more safely in shallower waters than the boats and there were no entanglement issues with propellers, divers and airlines to worry about.

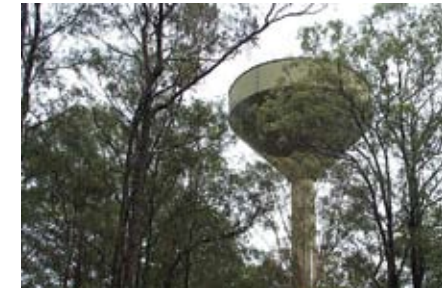
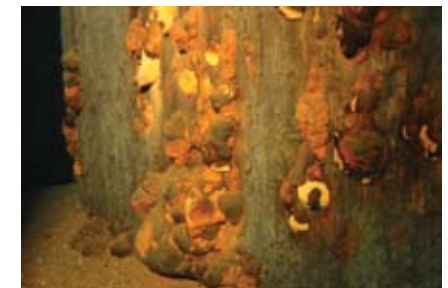
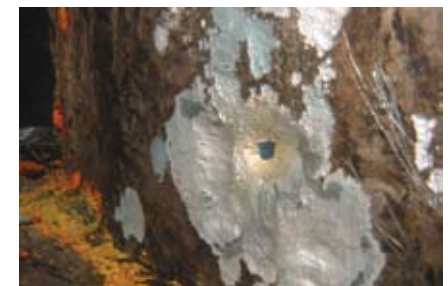
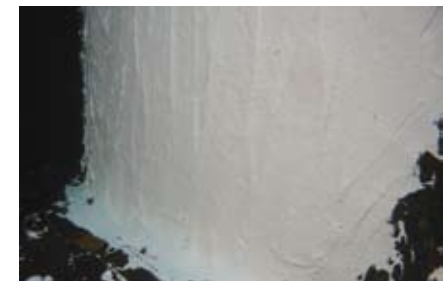
**A 'wine glass' shaped reservoir thirty metres above the ground was displaying seepage through the centre access tunnel. This tank could not be removed from service, so any repairs had to be carried out while the tank remained full of water.**

Internal inspection using a potable dedicated dive team revealed heavy localized corrosion to the tunnel wall area, adjacent to a brass protective screen covering the outlet penetration. The brass material was providing a strong cathodic reaction to the 8mm thick mild steel plating that comprised the access tunnel. After scraping back the bitumen protective coating and the corrosion nodules, a strong leak developed due to seven metres of water head pressure bearing on the affected area. A large adjacent area of tunnel wall was also identified as having less than 20 percent remaining of it's original plate thickness. A ten-cent coin was used to initially block the water flow. This was further sealed and held in place with 'Blue-Tac', which had sufficient viscosity to withstand the significant water pressure.

NMP 1720 underwater epoxy was applied over an area of 1 square metre to completely cover and re-enforce the weakened steel section of the tunnel. This epoxy was built up to an average thickness of 20mm around the affected areas without exhibiting any significant slumping. The Kevlar fibres incorporated in the epoxy will ensure the tank can now remain safely in service for several years, until the internal protective lining is replaced. The client, Sydney Water, was extremely pleased with the end result.
