## Renovating for Improved Water Quality

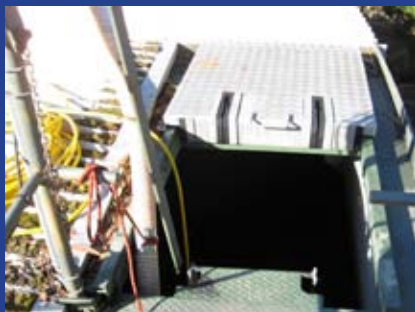
Entry hatch before

**Access hatches into storage tanks are the most common area where contaminants can enter into our drinking water.**

**There are four simple things that can be done to improve entry hatches.**

- 1. Cut off any protruding ladder stiles**
- 2. Install a sealed front edge**
- 3. Change sliding covers over to a hinged, overlapping type**
- 4. Improve the sealing capabilities around the hatch frame area**

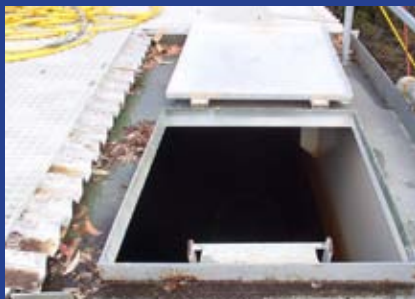
Entry hatch after

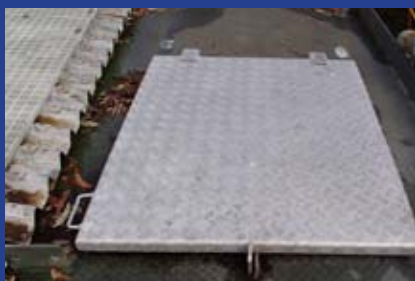
New entry hatch closed

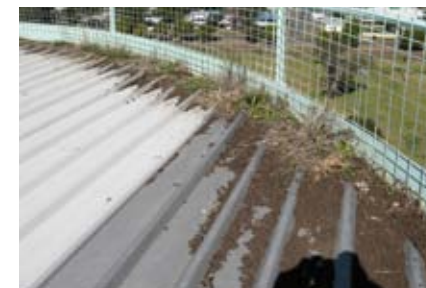
Many are not sealed where the roof sheets join up against the platform frame, allowing roof water to drain directly into the tank during rain fall events. Platforms also attract bird activity due to safety rails and aerials mounted close by. Faecal contamination then accumulates and drains or blows into the stored water supply.

Kick rail ponding

1. Platforms need to be 'tucked under' the roof sheets or have good upstream drainage fitted.
2. Kick rails can be lifted higher to reduce leaf debris blockages and subsequent back flow events.
3. Ponded areas can have an 'underdrain' system fitted that delivers accumulated water out through the wall area of the tank.
4. Hand rails can be simplified and aerials can be relocated to reduce the attraction to roosting birds.

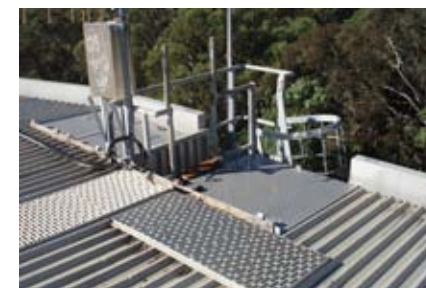
Before platform renovation

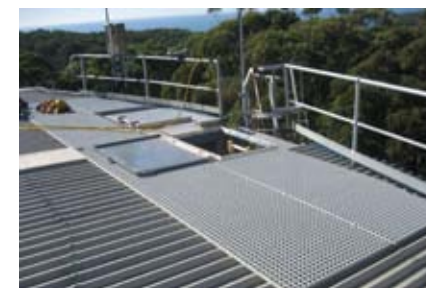
After platform renovation

Many platform designs were a compromise to the existing structure, when older tanks were roofed, so a complete re-design is the only effective method of overcoming the contamination issues. Good design is the cornerstone of this process and simply adding on 'bits and pieces' to existing poor designs will not solve the water security issues present on most of our tanks today.
