# CONTAMINATION

RESERVOIR  
MAINTENANCE  
SPECIALISTS

issue **14**

# AQUALIFT BUCKET OF WATER TEST

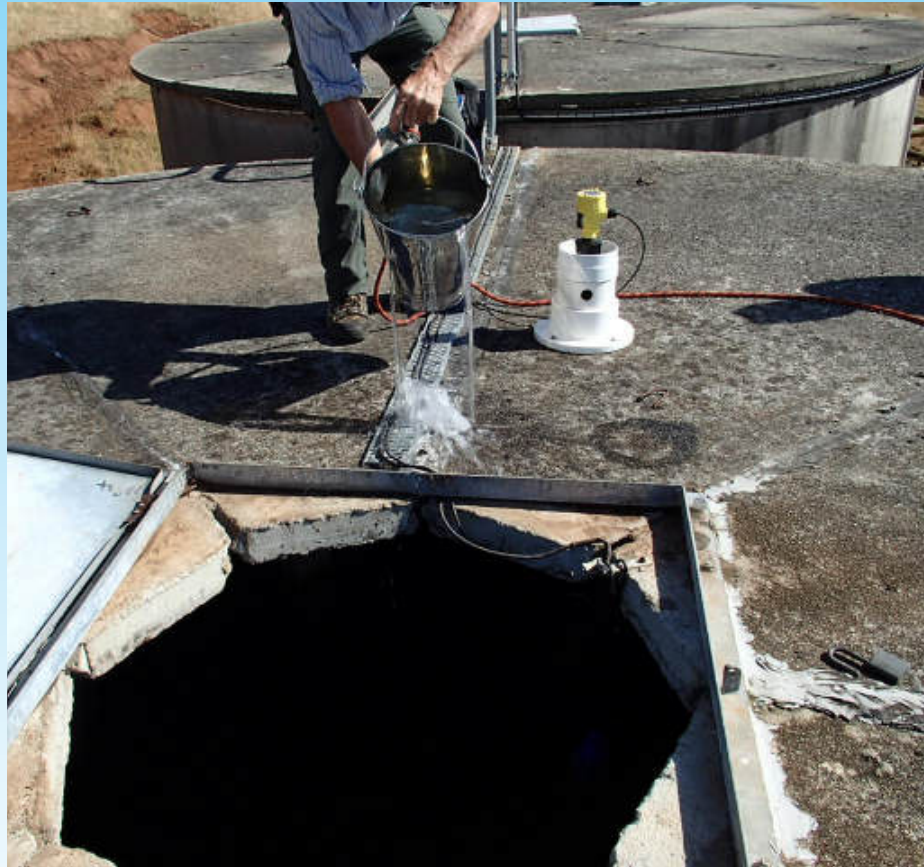
The first method is using a clean bucket and rope to obtain water from the tank and then pour it around any areas that should be sealed, such as platform edges, hatch frames and any fixtures set onto the roof area. And then look (and listen) inside the tank to see or hear any water ingress.

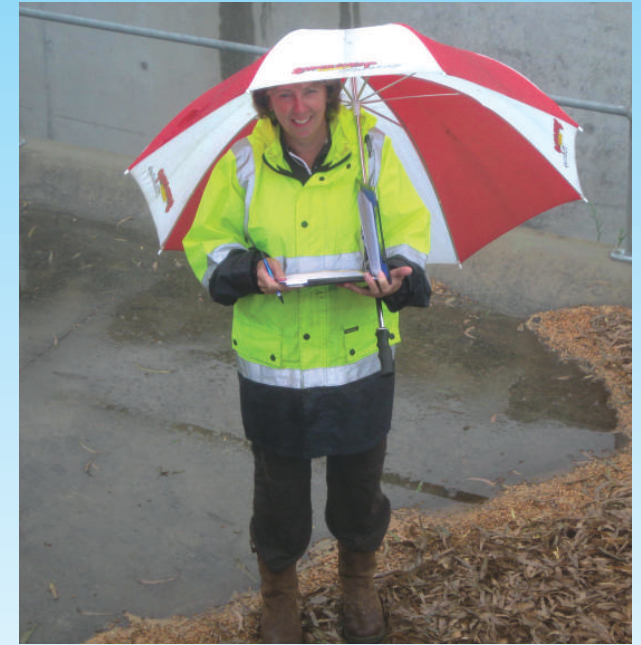
The second method will appeal to the technology minded person, as it involves 'The Cloud'.

This test requires protective equipment to be worn, as it involves... standing out in the rain (the original cloud technology) and watching all that natural water, mixed with contaminants draining back into all sorts of 'un-guessed at' places!

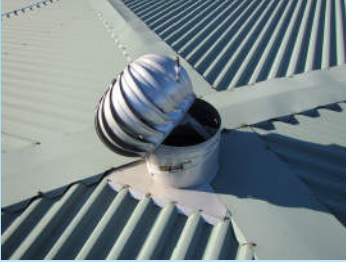
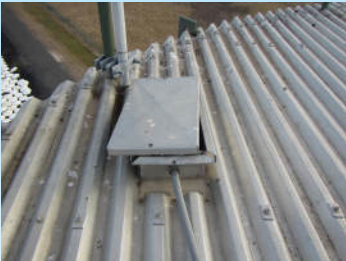
# CONTAMINATION POINTS

Storage tanks are a significant contributor to contamination entry within a reticulation system. Having an enclosed storage does not guarantee good water quality, as many factors are involved in a typical roofing system. Entry hatches, work platforms, box gutters, ventilation fixtures, cable and pipework penetrations can all cause failures in effective tank sealing.
