### Renovating for Improved Water Quality

Renovation and Water Quality

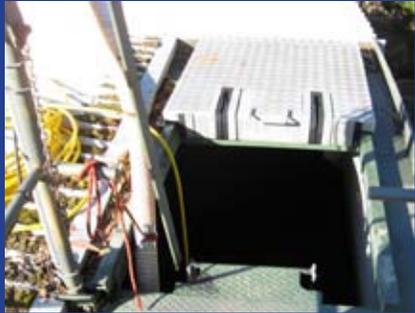
Entry hatch before

**Access hatches into storage tanks are the most common area where contaminants can enter into our drinking water.**

- 1. Cut off any protruding ladder stiles**
- 2. Install a sealed front edge**
- 3. Change sliding covers over to a hinged, overlapping type**
- 4. Improve the sealing capabilities around the hatch frame area**

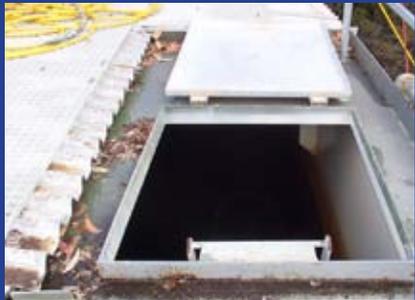
Entry hatch after

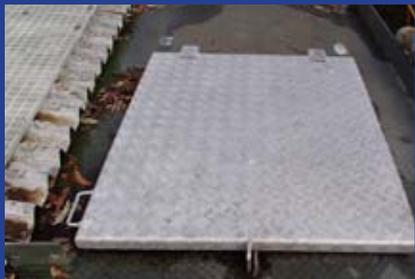
New entry hatch closed

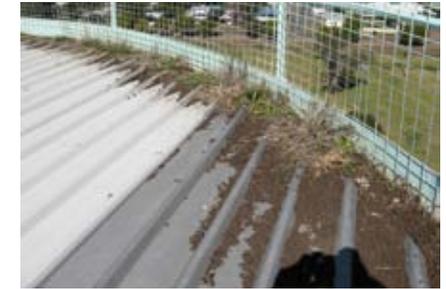
Kick rail ponding

1. Platforms need to be 'tucked under' the roof sheets or have good upstream drainage fitted.
2. Kick rails can be lifted higher to reduce leaf debris blockages and subsequent back flow events.
3. Ponded areas can have an 'underdrain' system fitted that delivers accumulated water out through the wall area of the tank.
4. Hand rails can be simplified and aerials can be relocated to reduce the attraction to roosting birds.

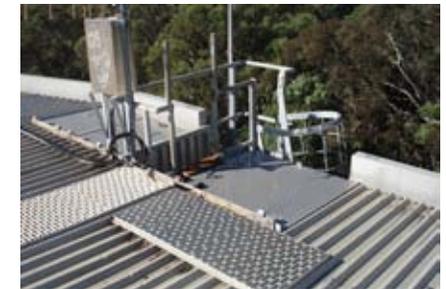
Before platform renovation

Many are not sealed where the roof sheets join up against the platform frame, allowing roof water to drain directly into the tank during rain fall events. Platforms also attract bird activity due to safety rails and aerials mounted close by. Faecal contamination then accumulates and drains or blows into the stored water supply. Several things can be done to reduce contamination potentials.

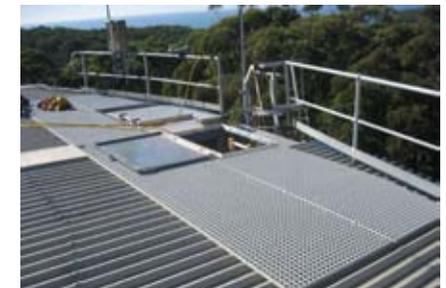
After platform renovation

Many platform designs were a compromise to the existing structure, when older tanks were roofed, so a complete re-design is the only effective method of overcoming the contamination issues. Good design is the cornerstone of this process and simply adding on 'bits and pieces' to existing poor designs will not solve the water security issues present on most of our tanks today.
