## **Unsuitable Outcomes Top 10 – and still counting:**

There appears to be a new mentality of cut and paste design occurring in our current reservoir constructions. Old mistakes, unsuitable materials and poor building methods seem to be reappearing again, after a period of relatively good outcomes.

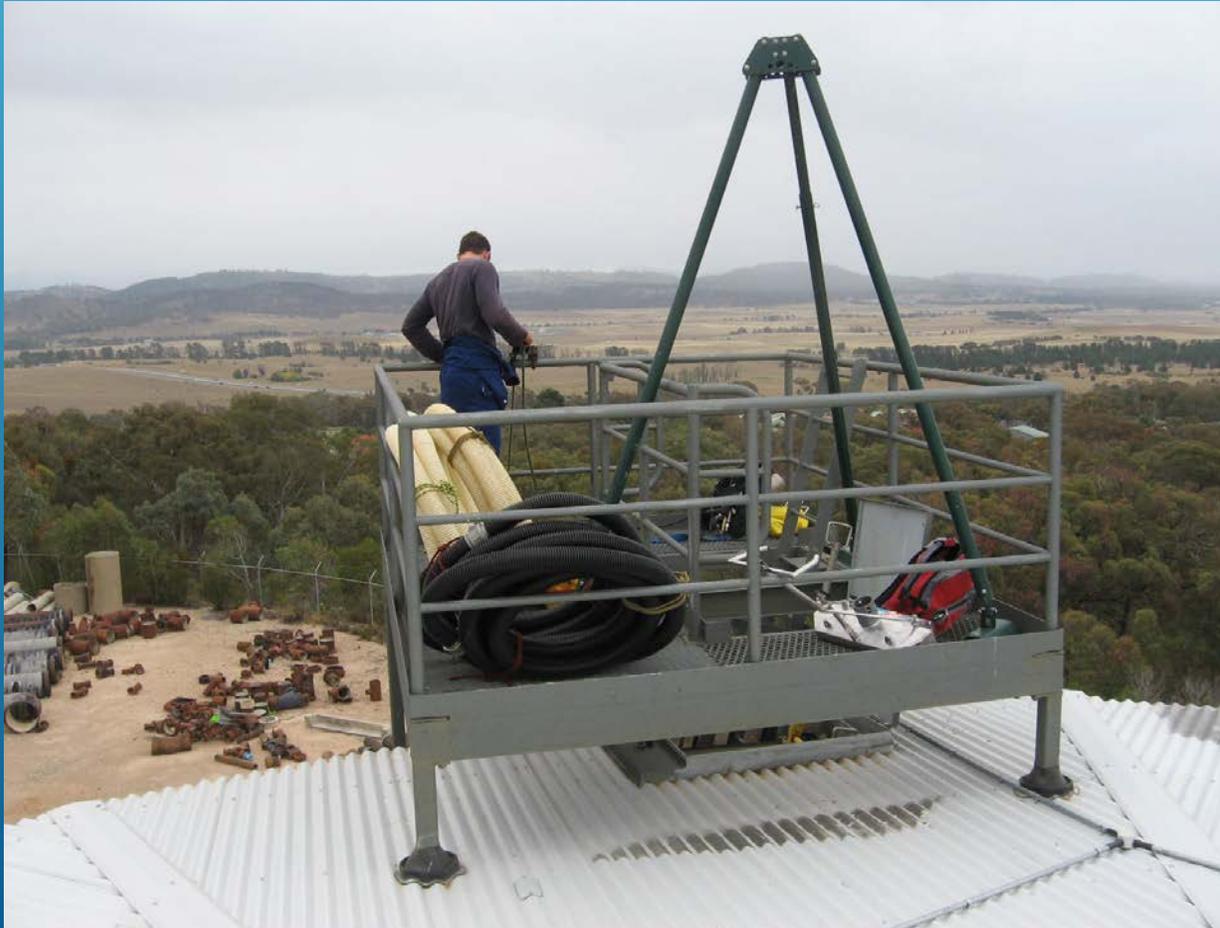
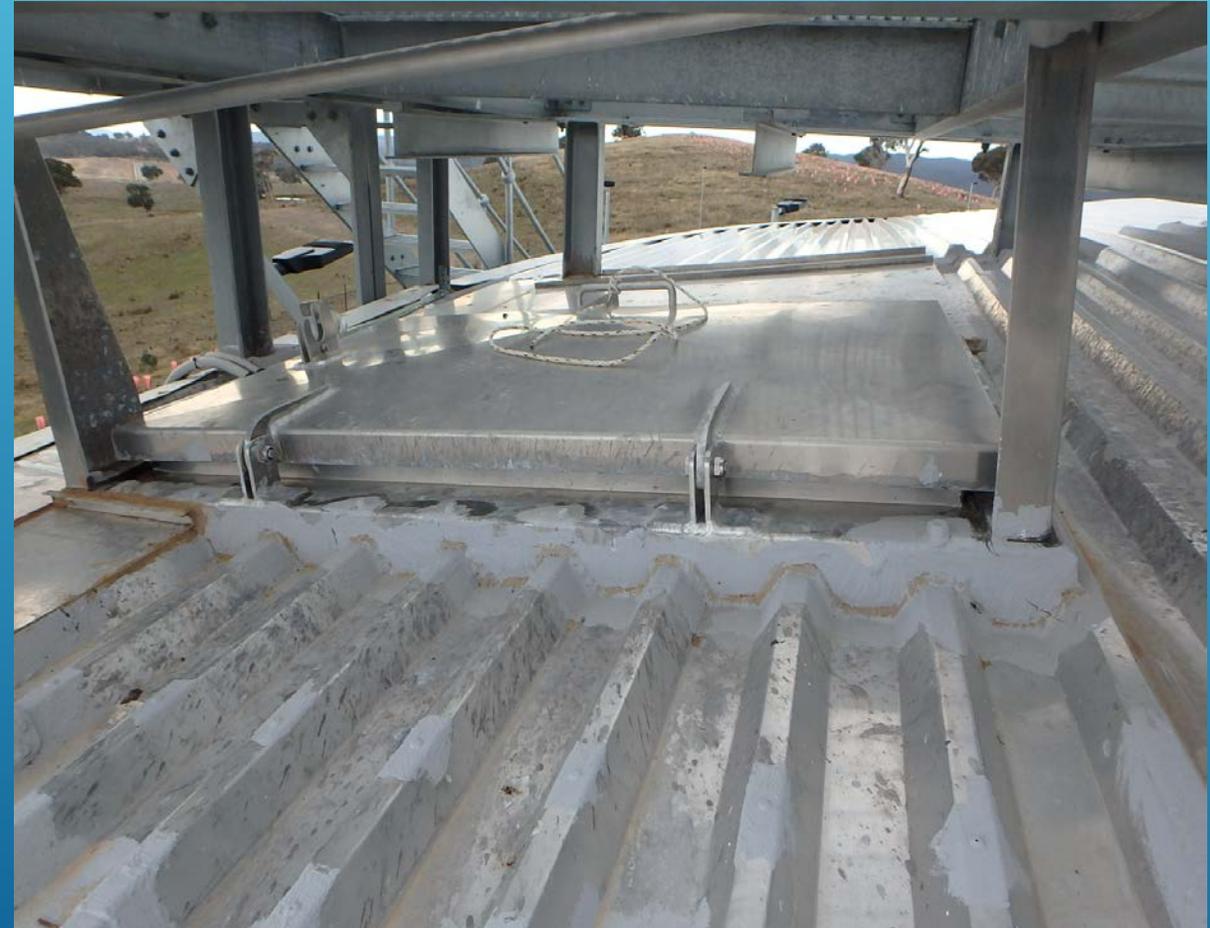
**Number 1:** Platform and entry hatch designs that limit working space and safe access into and out of the tank. What may be suitable for a factory environment is different to an elevated, confined space application, where diving and rescue equipment is commonly used. Platforms mounted high over the entry hatch area, instead of being level with the roof.

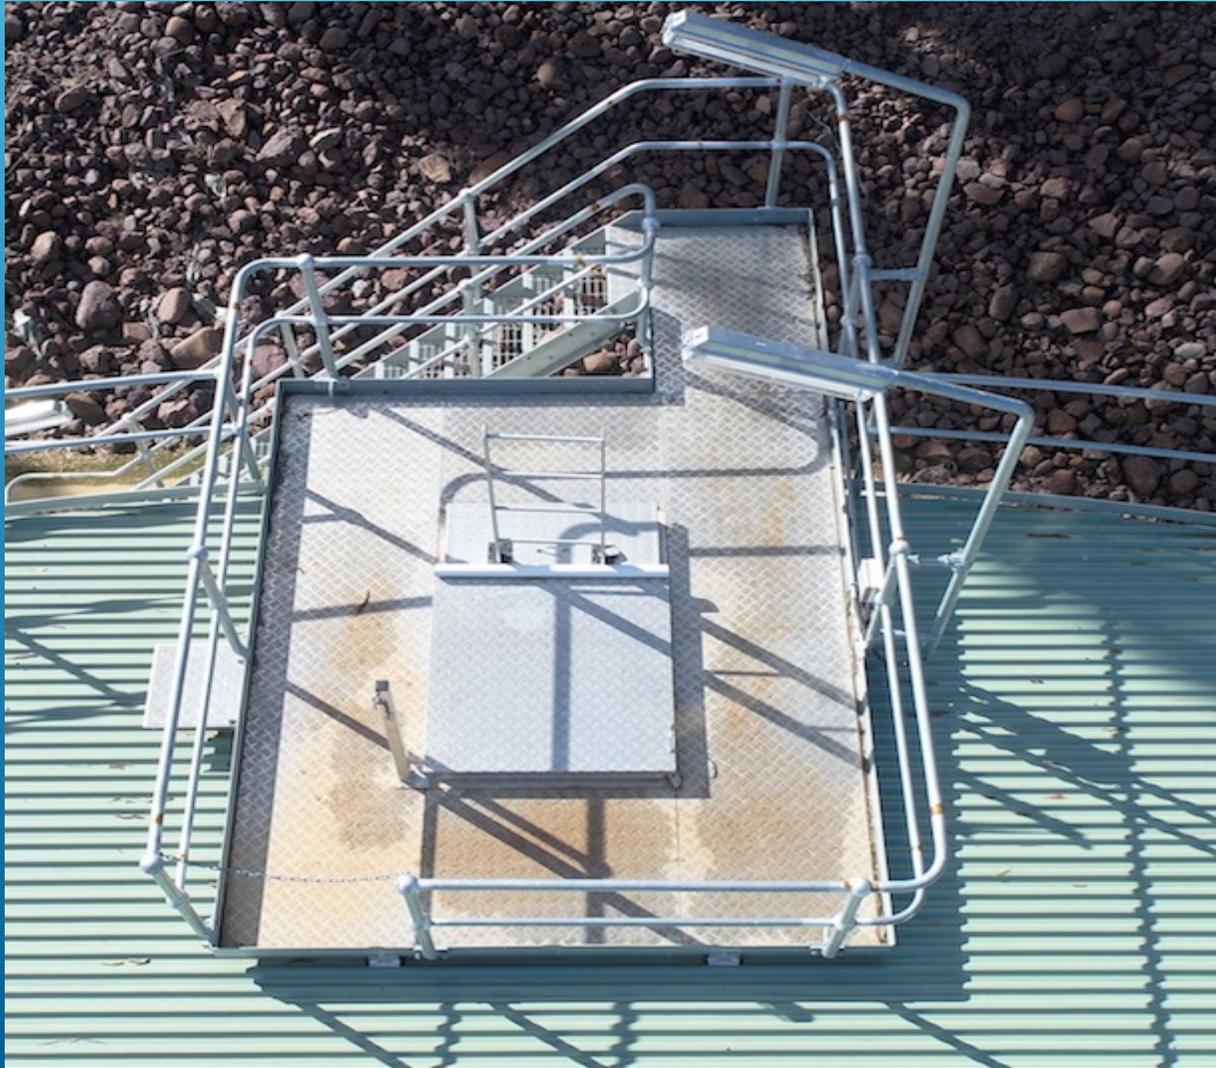
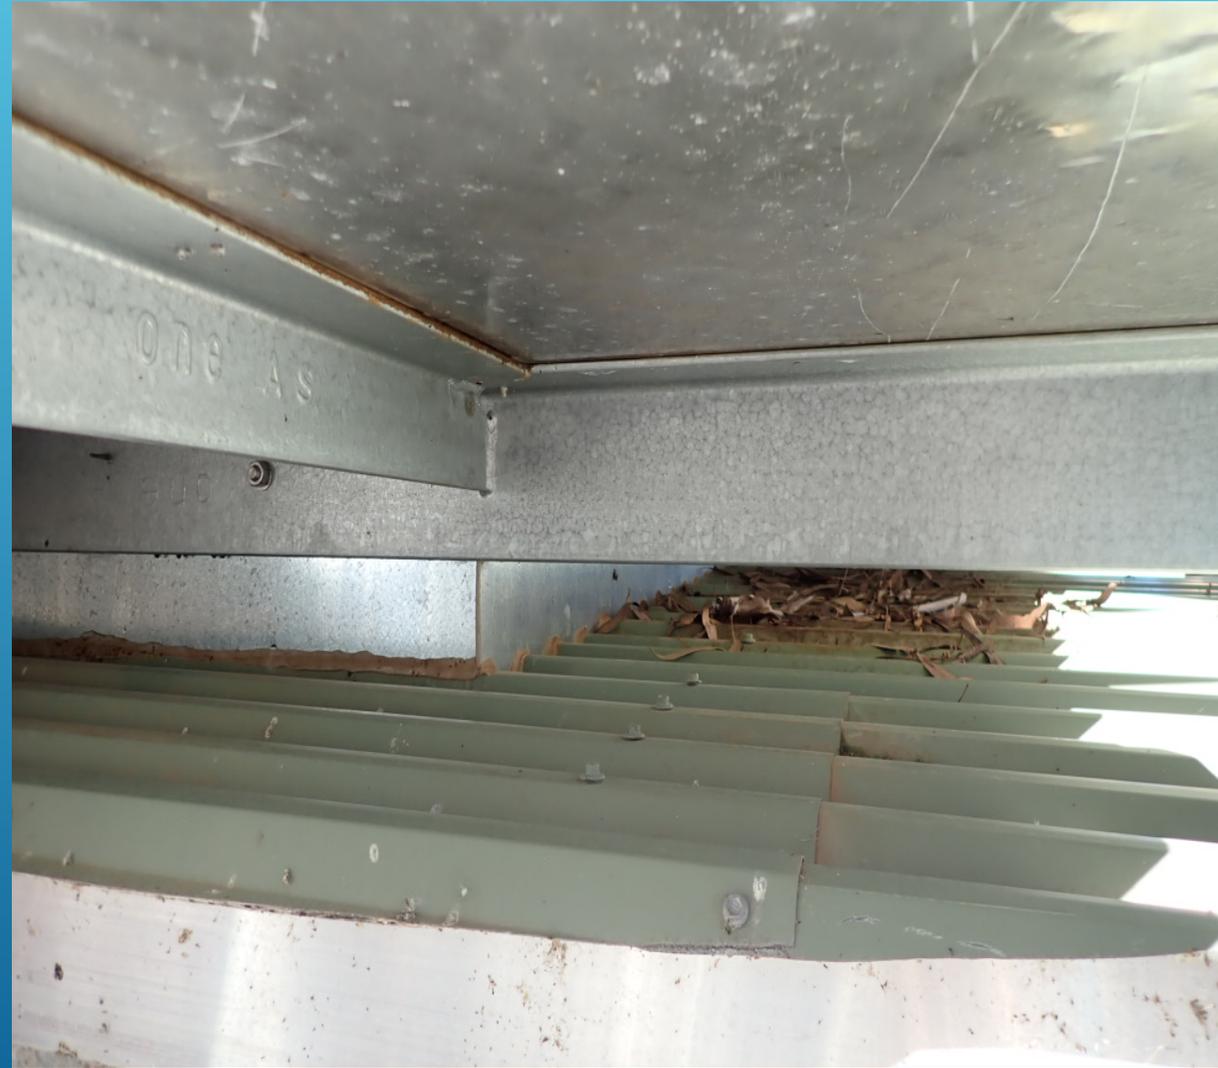
This platform sits just above the roof area, which creates a safe habitat for birds to nest below it and for leaf debris to build up and damage the roof sheets. The hatch frame is also only sealed onto the roof sheet edges with mastic and there is no easy access to repair it when it deteriorates and allows the localized contaminants to enter into the tank.

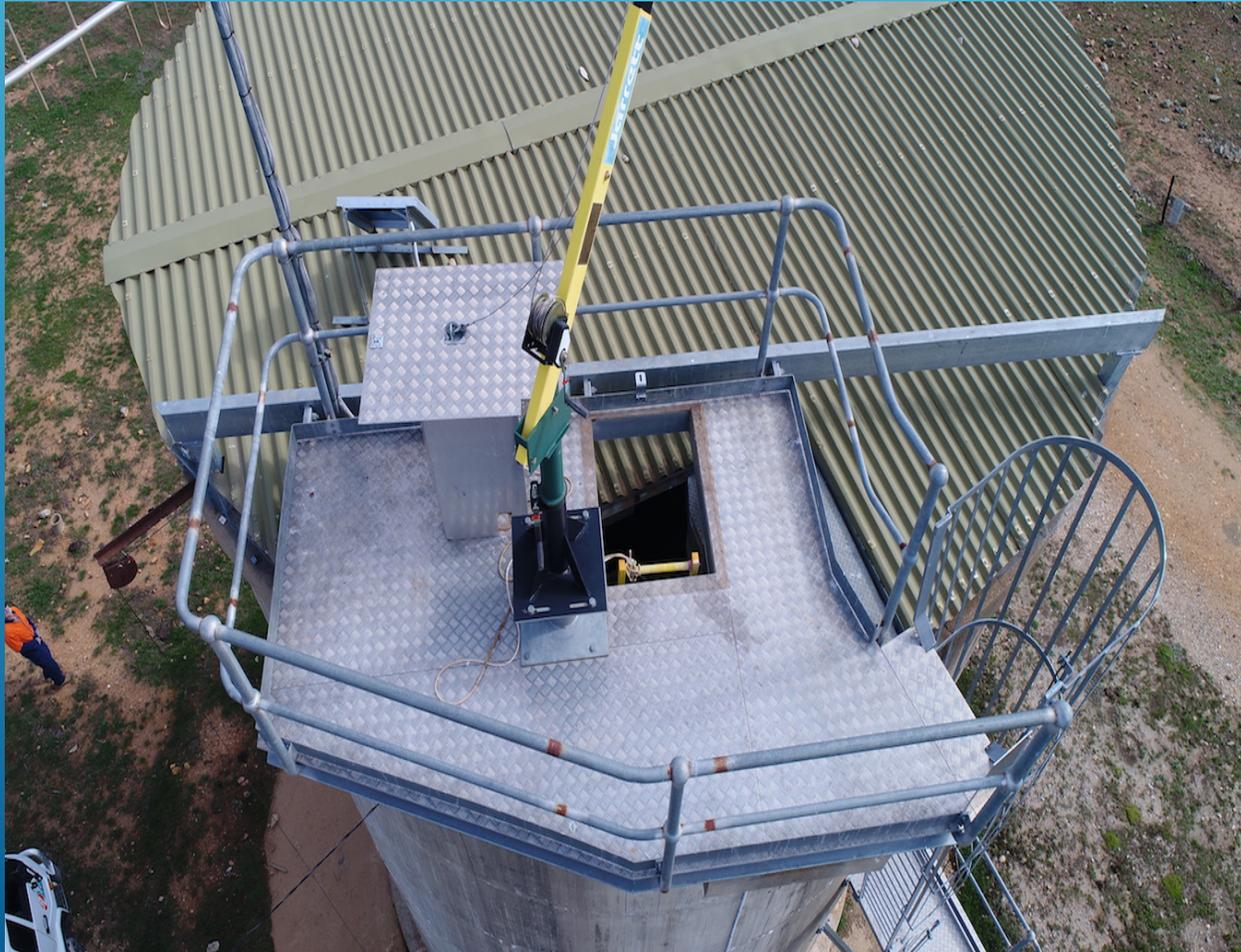
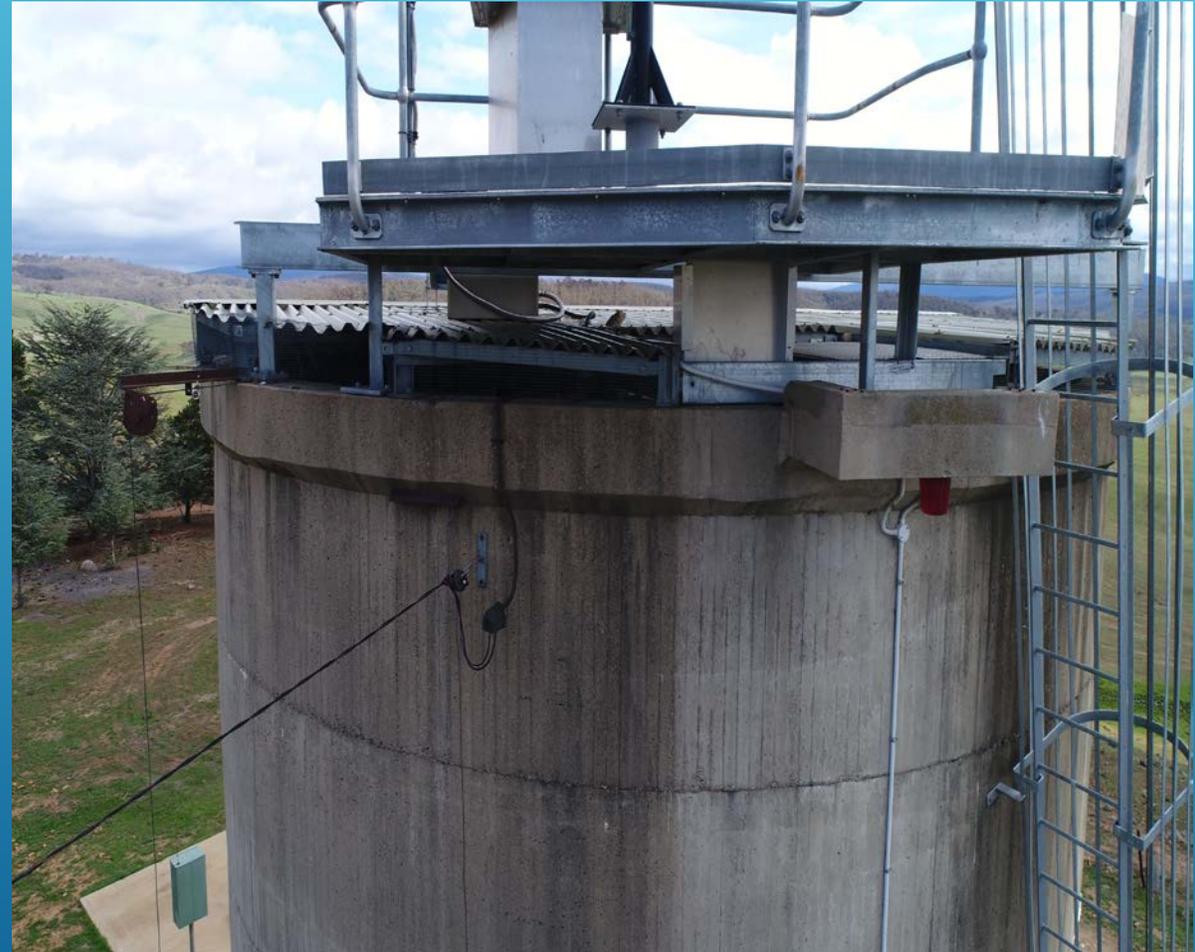
The worst platform outcome identified to date! A new platform was constructed over the top of the existing one, which was partially removed, leaving a large unsealed area leading directly into the tank.

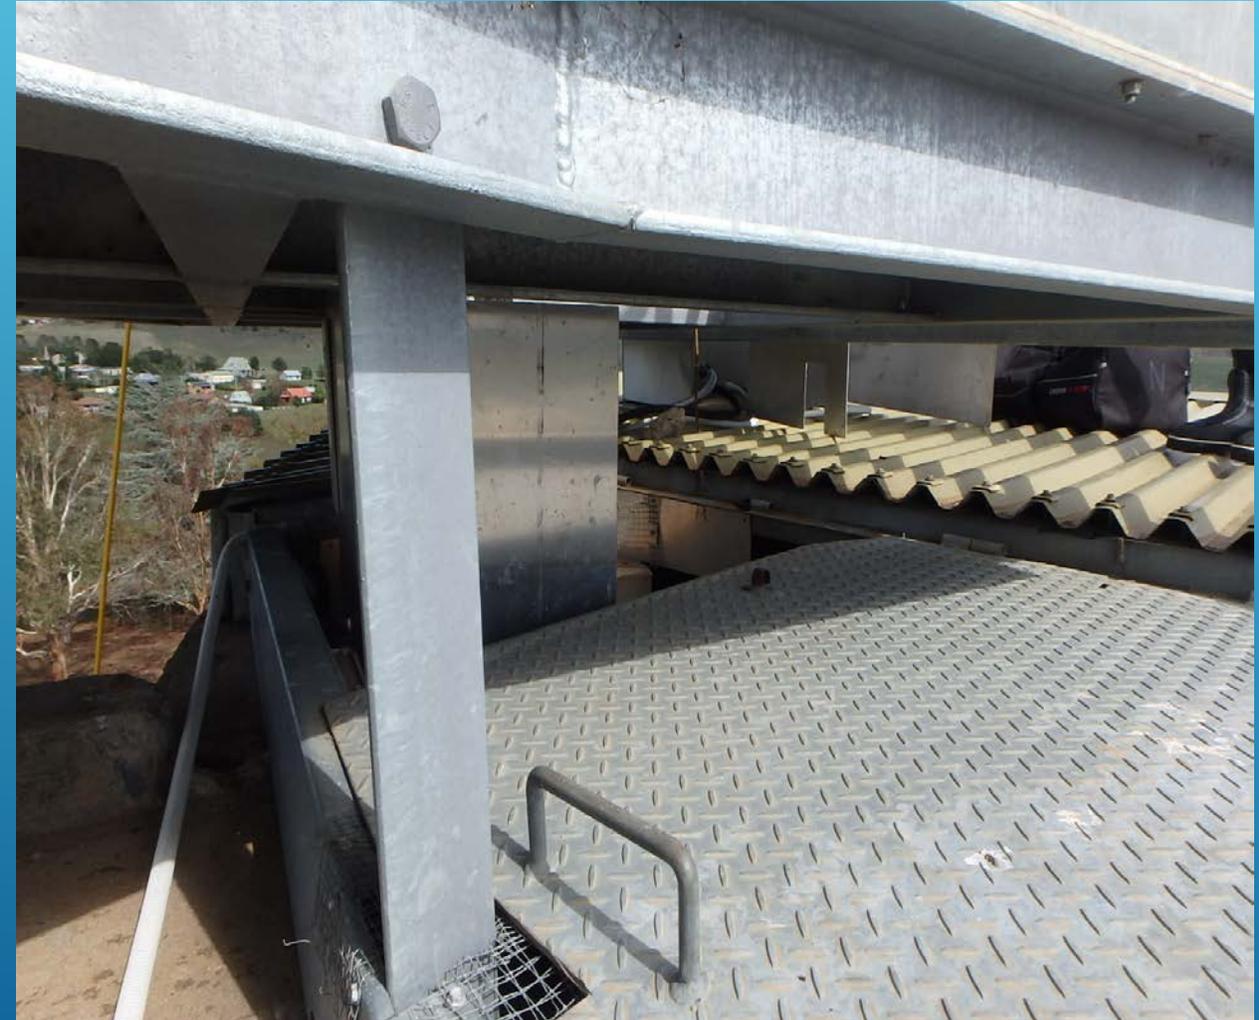
The entry hatch cover was then made up as an extended section and dropped down into the open roof hole. While it wasn't sealed onto the new platform area around the edges, below the platform was a far worse sealing issue!

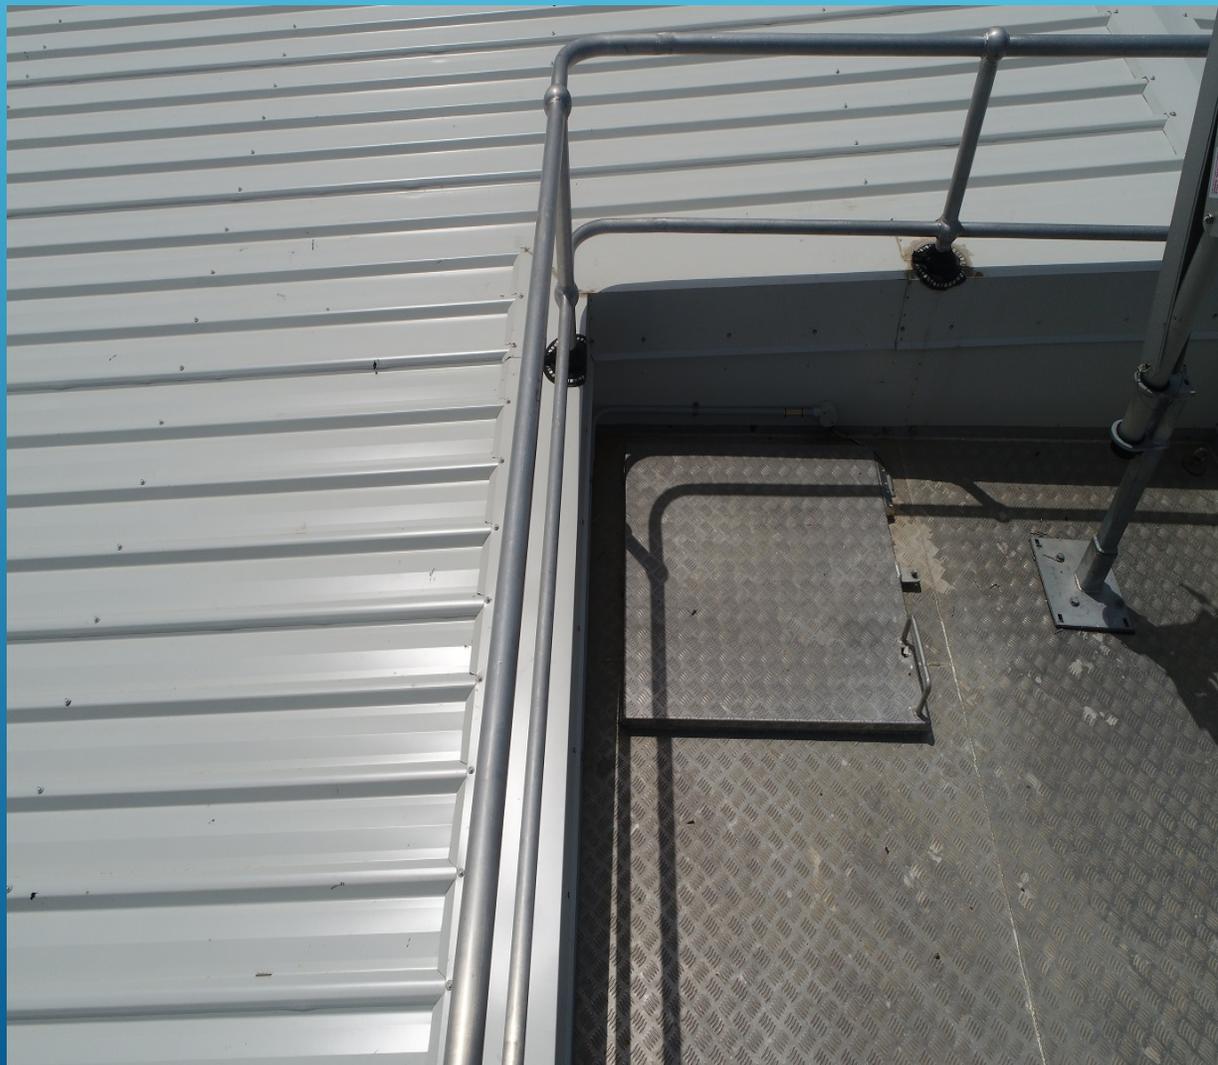
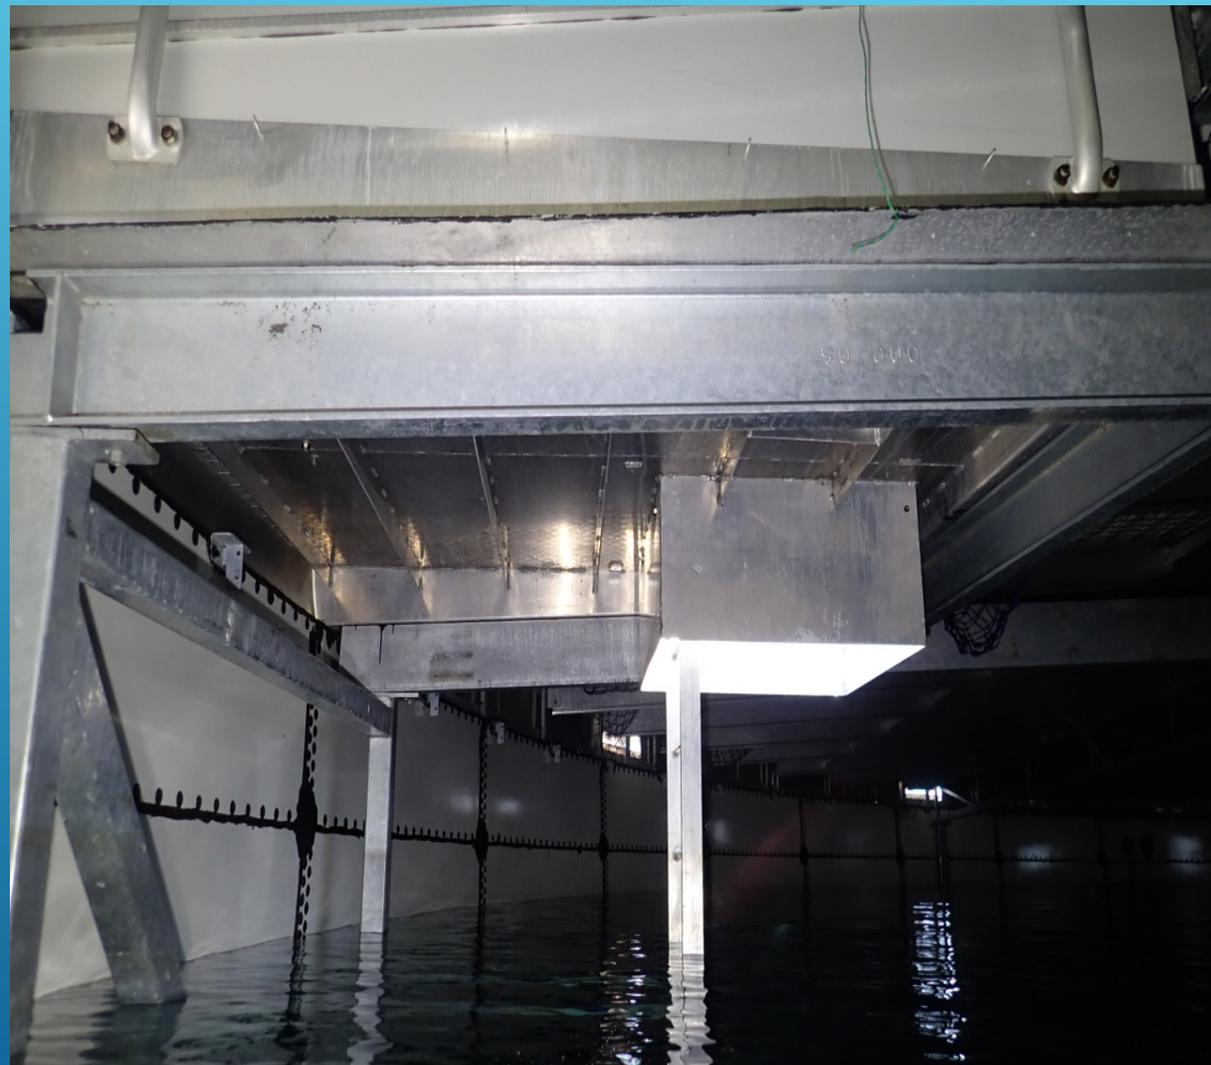
Entry hatches mounted too far off the wall, so that ladder supports have to be extended to accommodate the excessive distance.

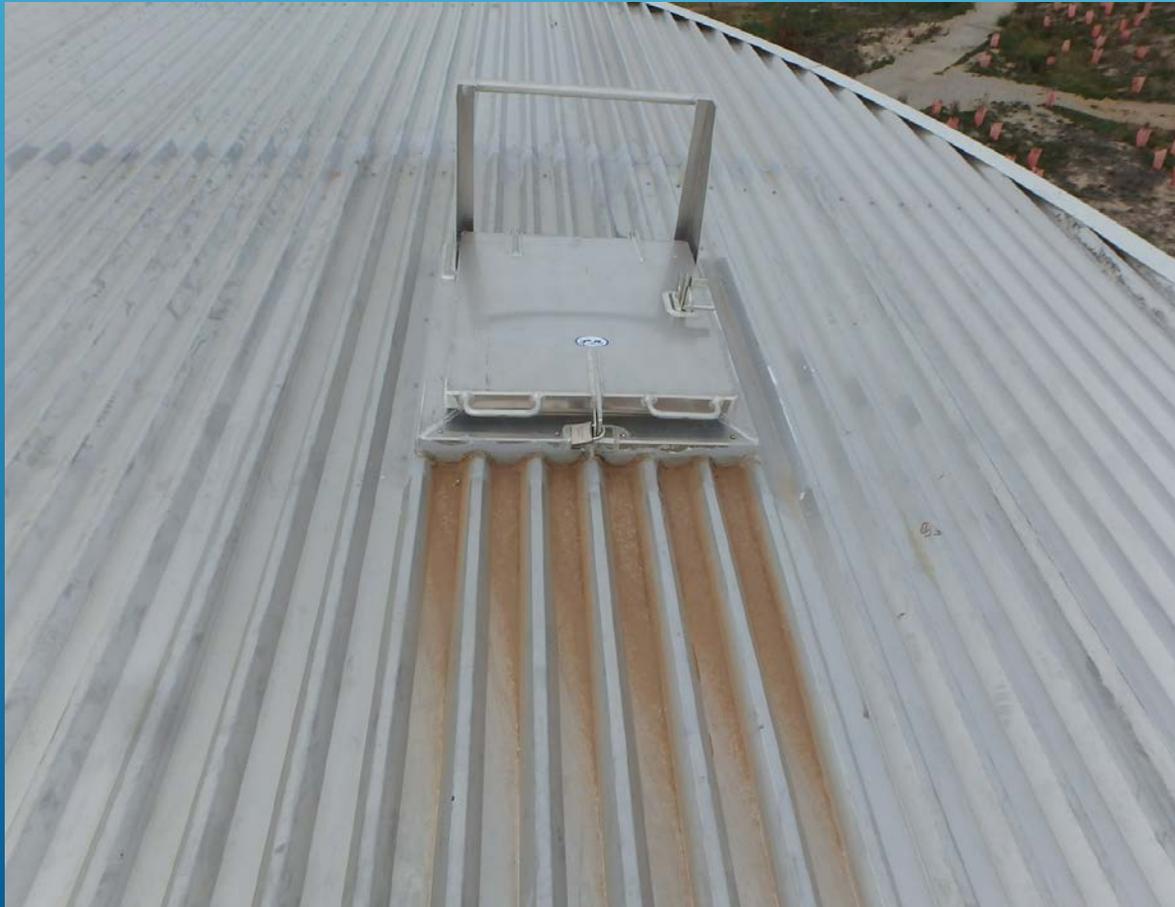
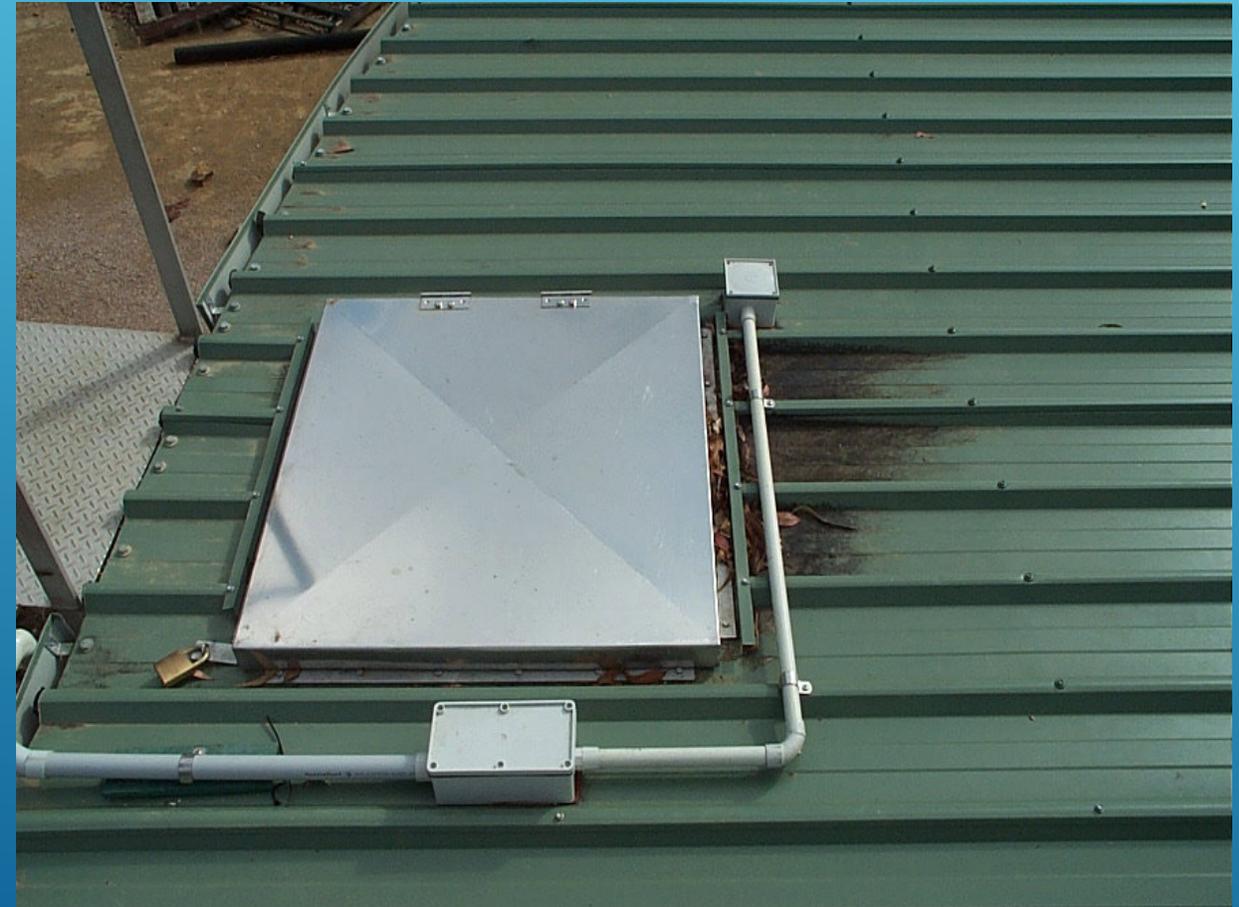
**Number 2:** Roofing that allows rain water and associated contamination to enter into the tank. Platform and hatch areas are commonly unsealed and allow debris to accumulate on the upstream edges, causing ponding and roof sheet deterioration. It is often assumed that a bit of extra water will be a bonus in these dry times, but would tanks storing wine or grain allow water to flow in or would a house holder or factory owner accept rain water entering into their building?

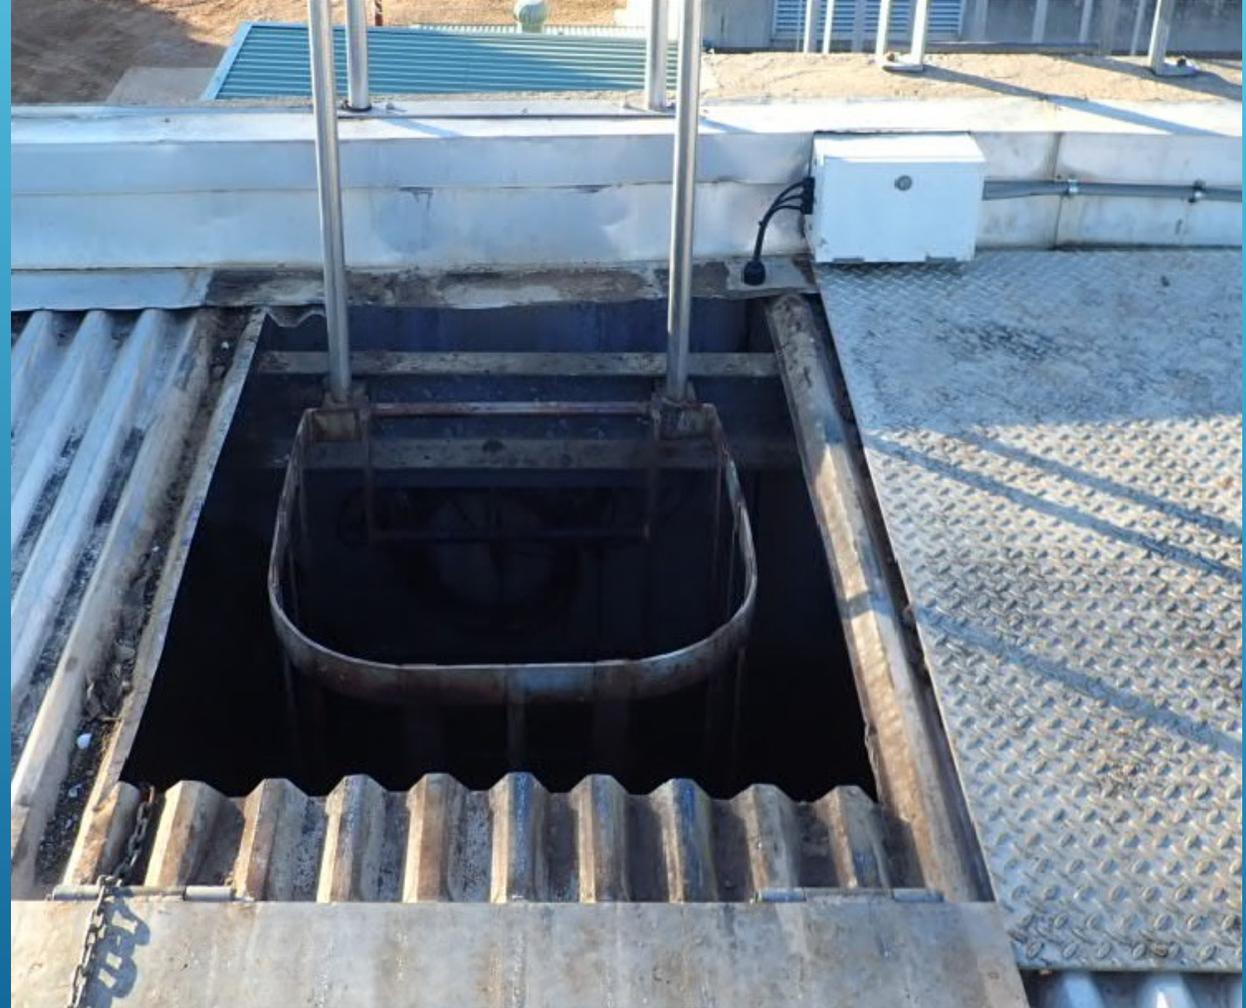
This entry hatch cover sits directly on top of the roof sheets with no frame or sealing mechanism in place around the edges. The internal ladder stiles extend through the unsealed hatch cover. The tank also has a significant amount of local bird activity and their faecal contamination is entering directly into the stored water.

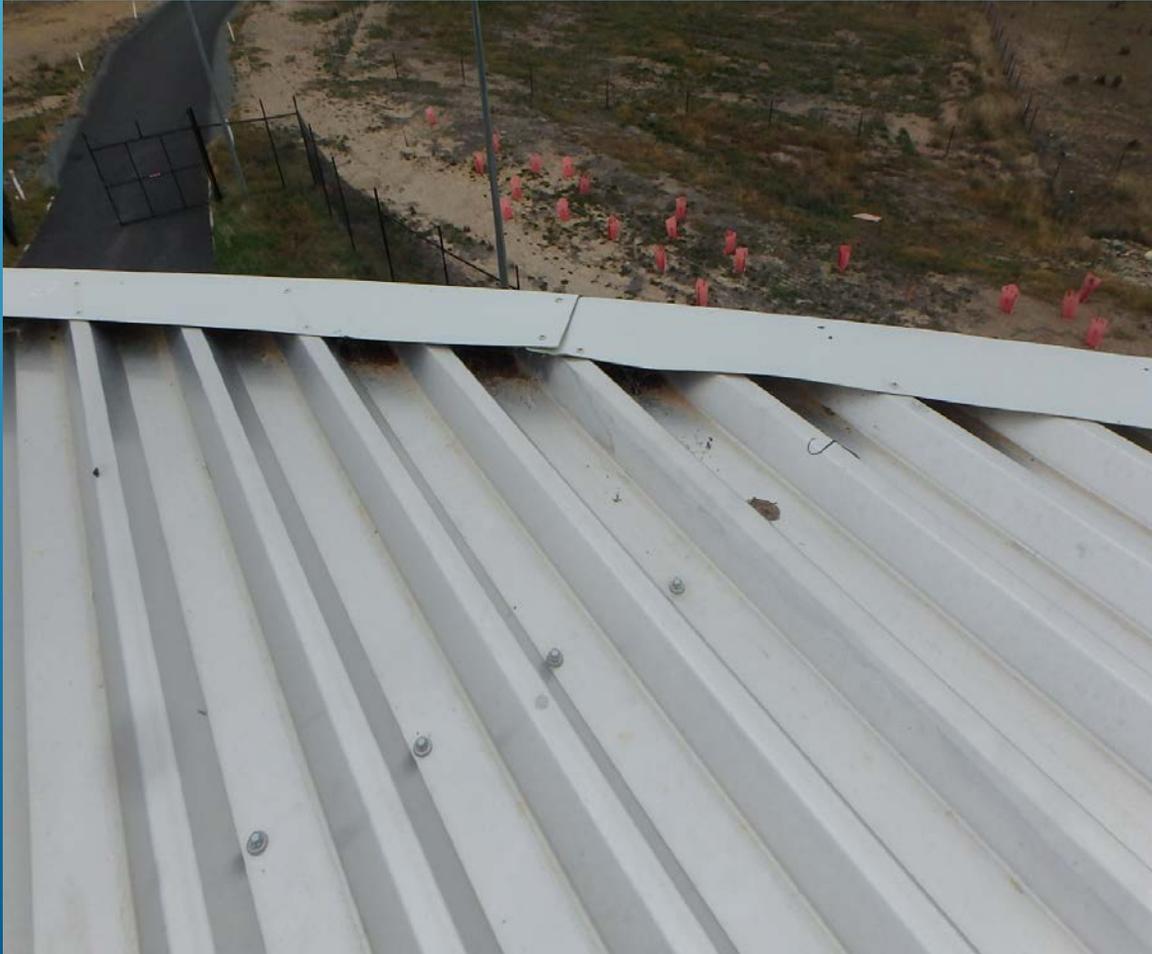
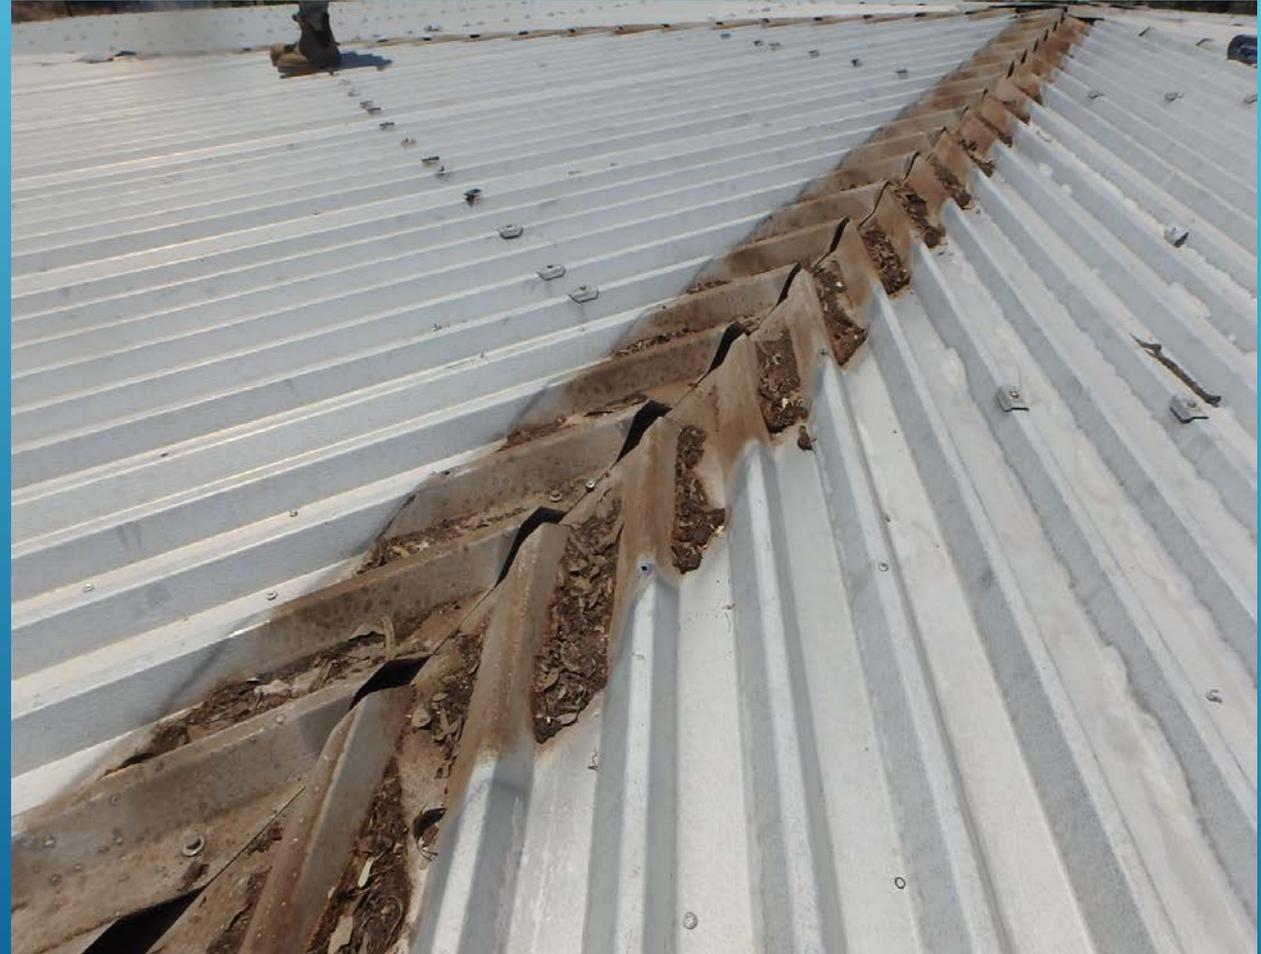
Flashings on the edge of roof areas prevent rain water from draining off and ridge cap flashings are difficult to seal and allow all sorts of debris, bird nesting and vermin entry to occur.

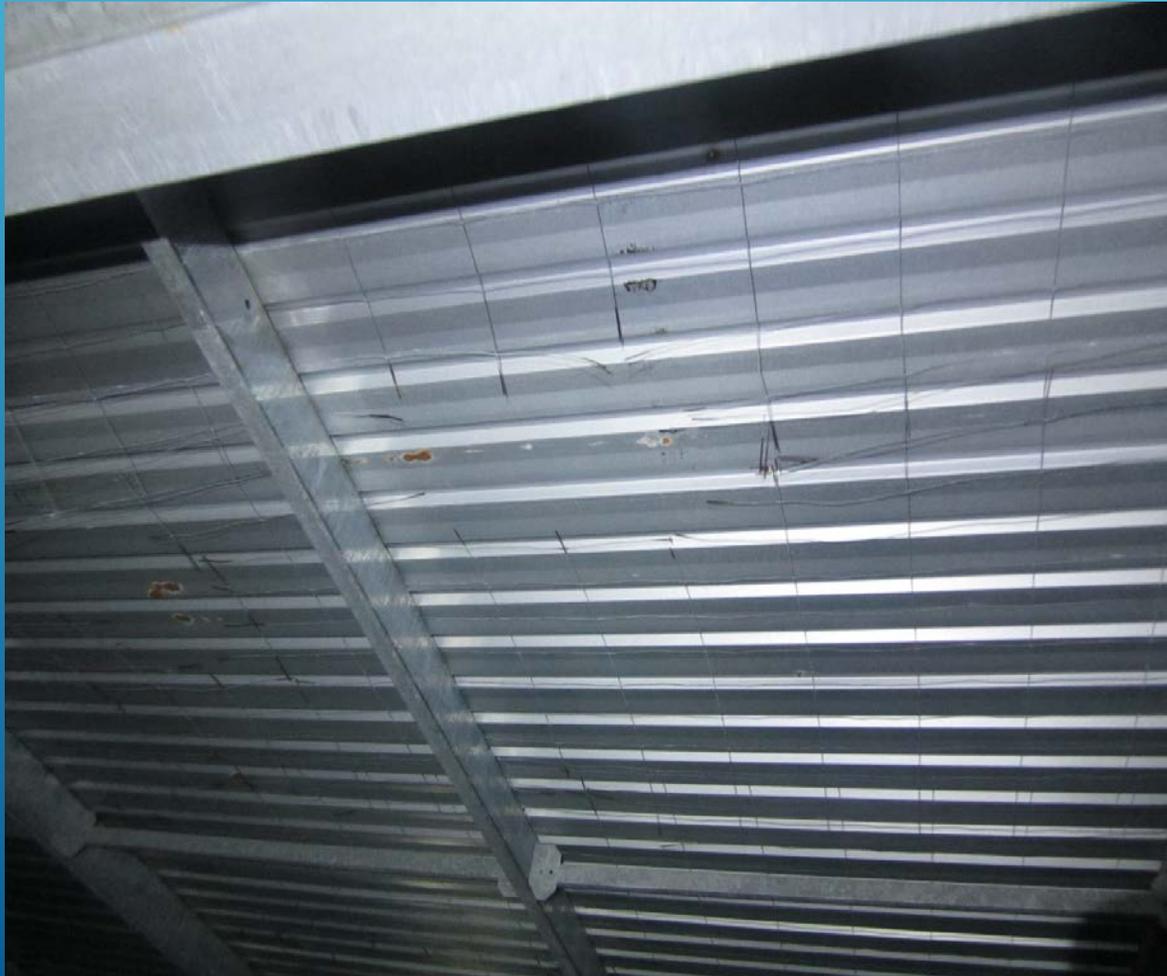
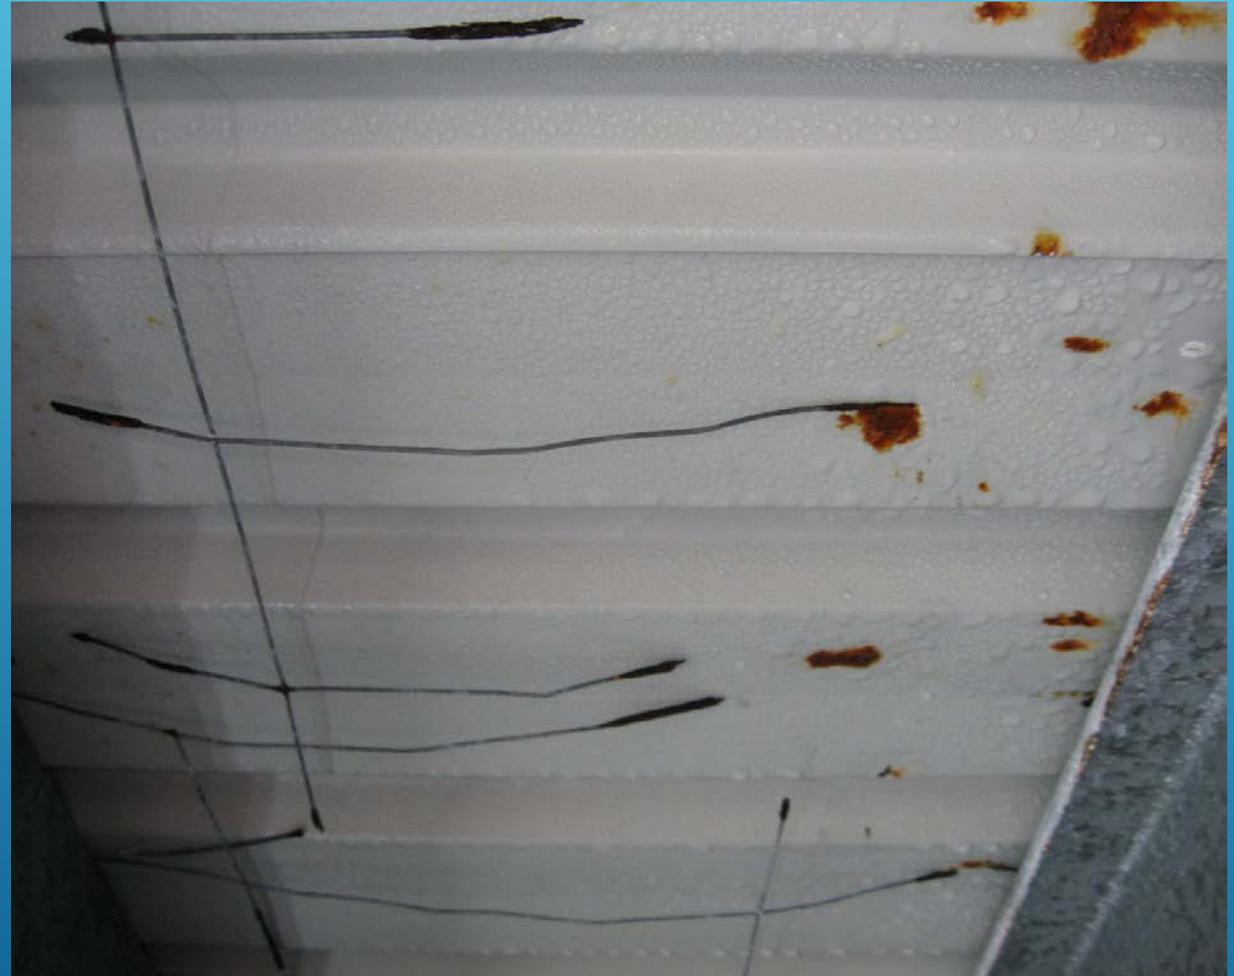
**Number 3:** Placing safety mesh under the roof sheets to comply with OH&S during construction. This material is usually the cheapest available and corrodes quickly, causing the roof sheets to fail and then dropping the debris down into the tank and making regular cleaning of the floor difficult. In a factory situation, there would have been a layer of insulation between the mesh and the roof sheets.

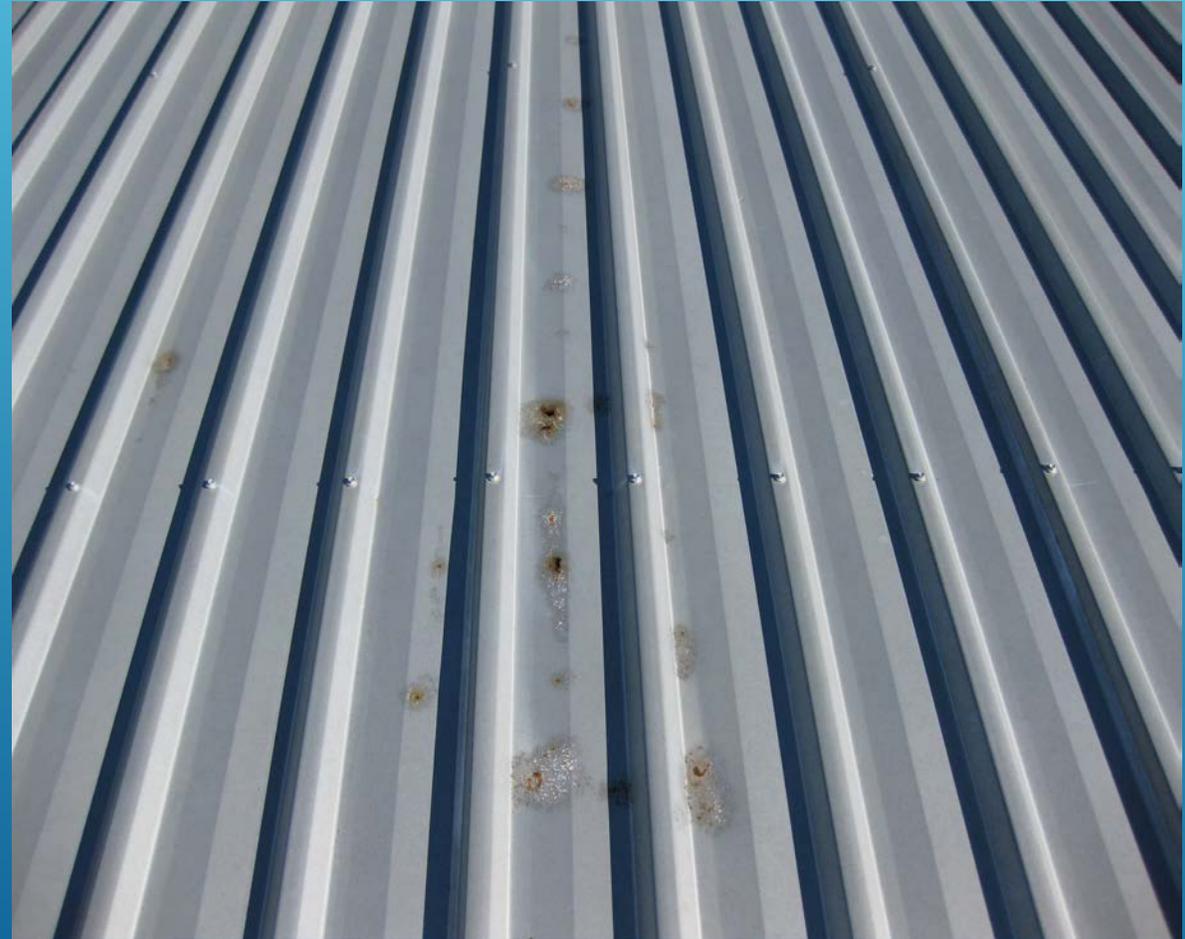
The corroded safety mesh breaks away and drops down onto the floor area, making effective tank cleaning a near impossible task. It also corrodes the roof sheets from the underside, leading to structural failure and an unsealed roof surface.
