## **Unsuitable Outcomes Top 10 – and still counting:**

There appears to be a new mentality of cut and paste design occurring in our current reservoir constructions. Old mistakes, unsuitable materials and poor building methods seem to be reappearing again, after a period of relatively good outcomes.

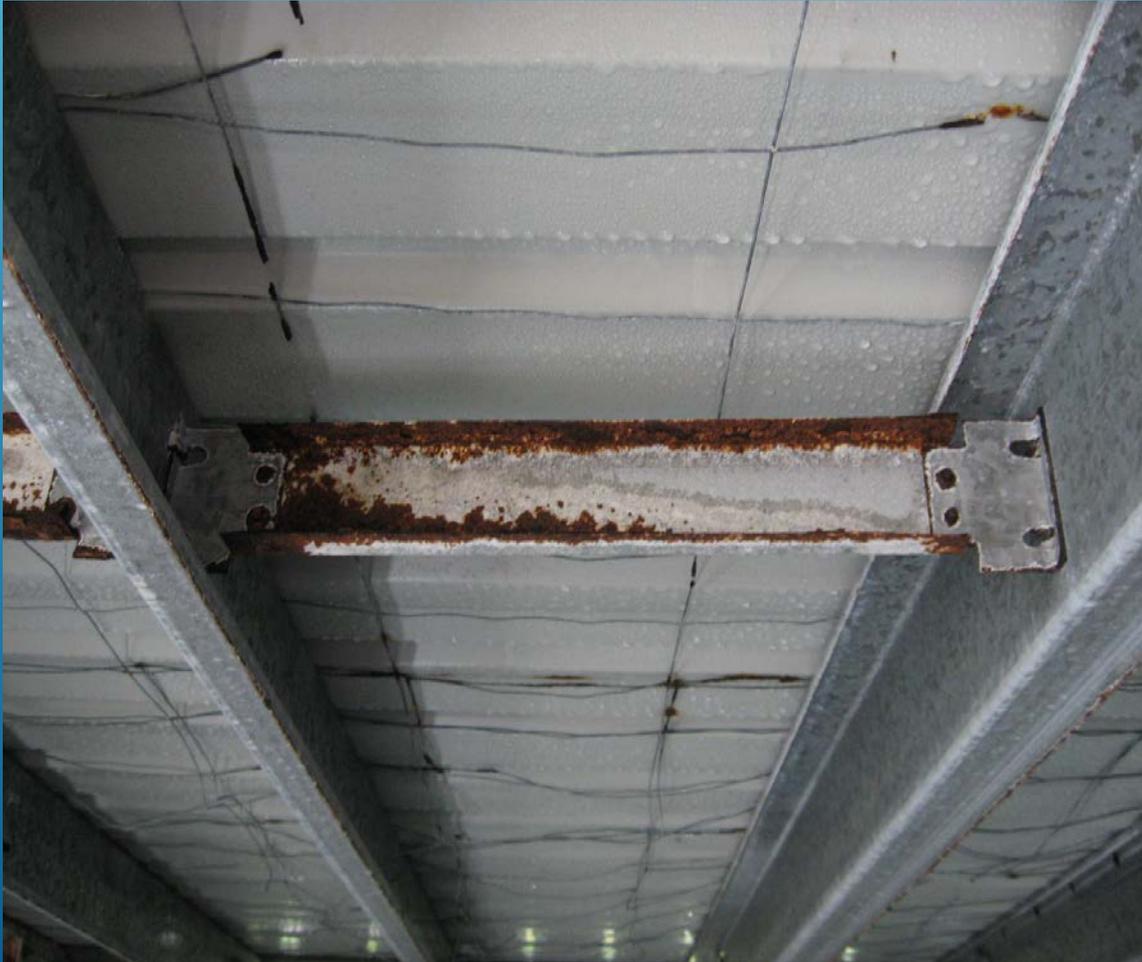
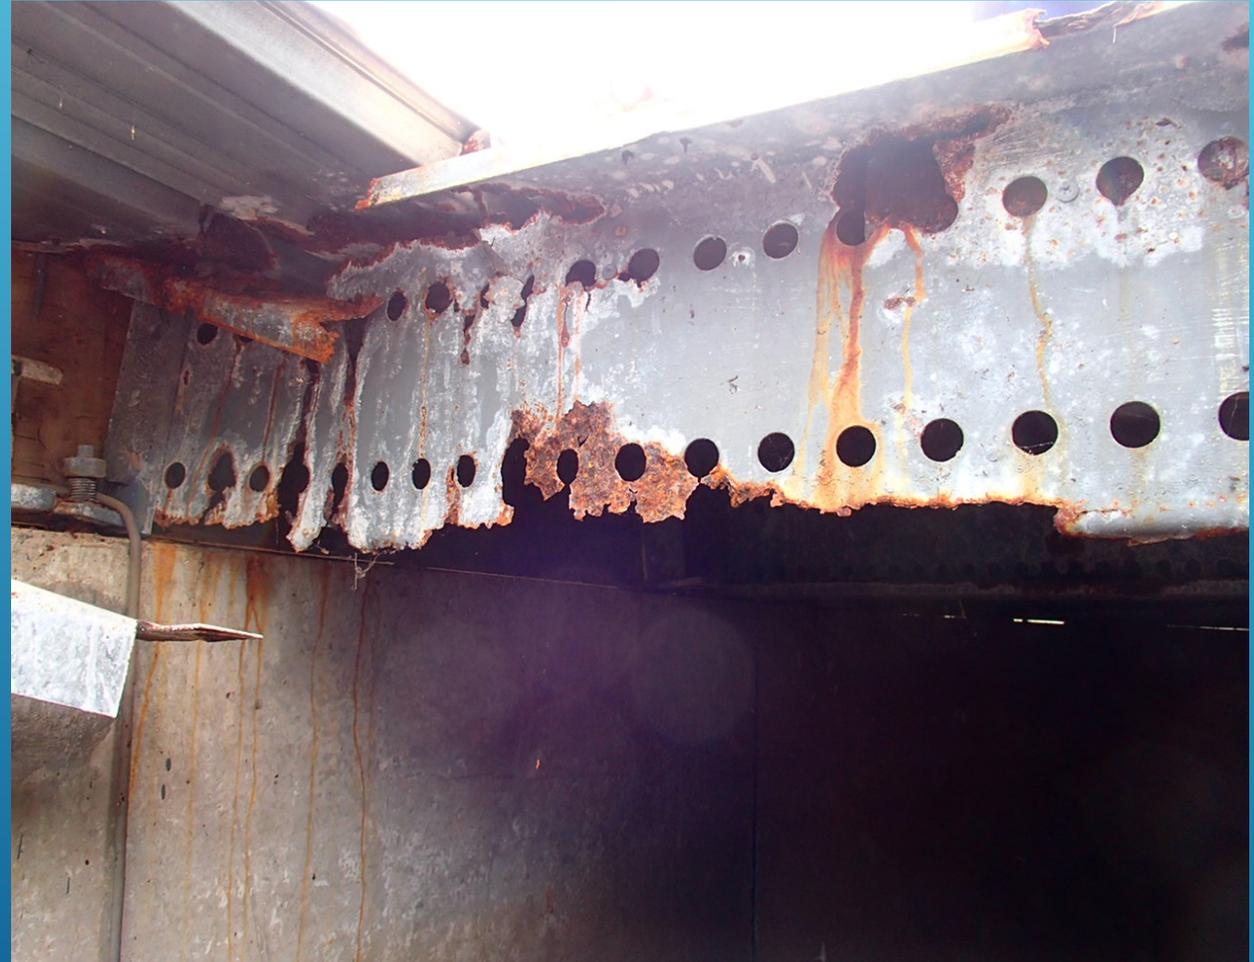
**Number 4:** Using roof framing materials that are not suitable for hot, moist and gaseous conditions. Zincalume coated purlins and rafters have a short life span in these situations and they also deteriorate quickly when roof screws puncture the surface coating.

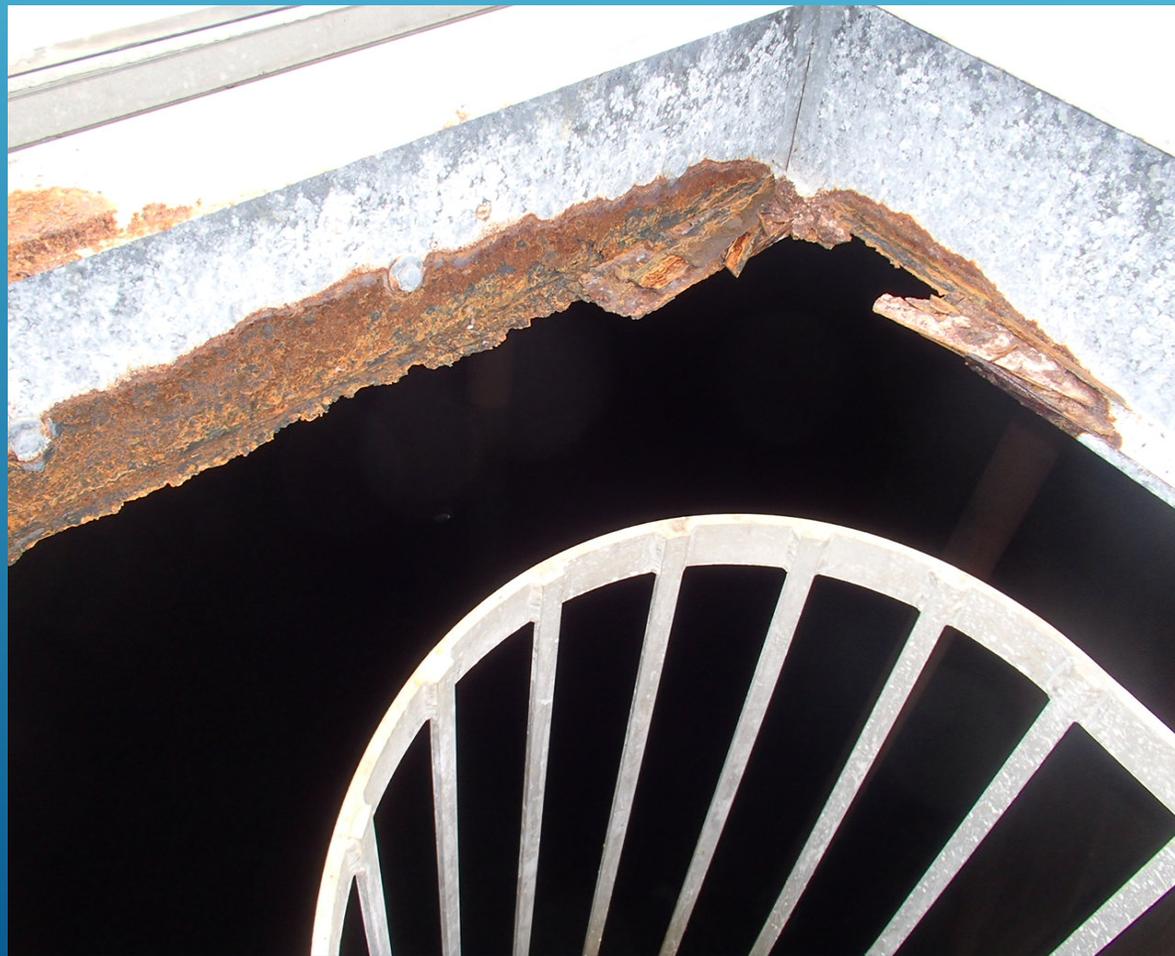
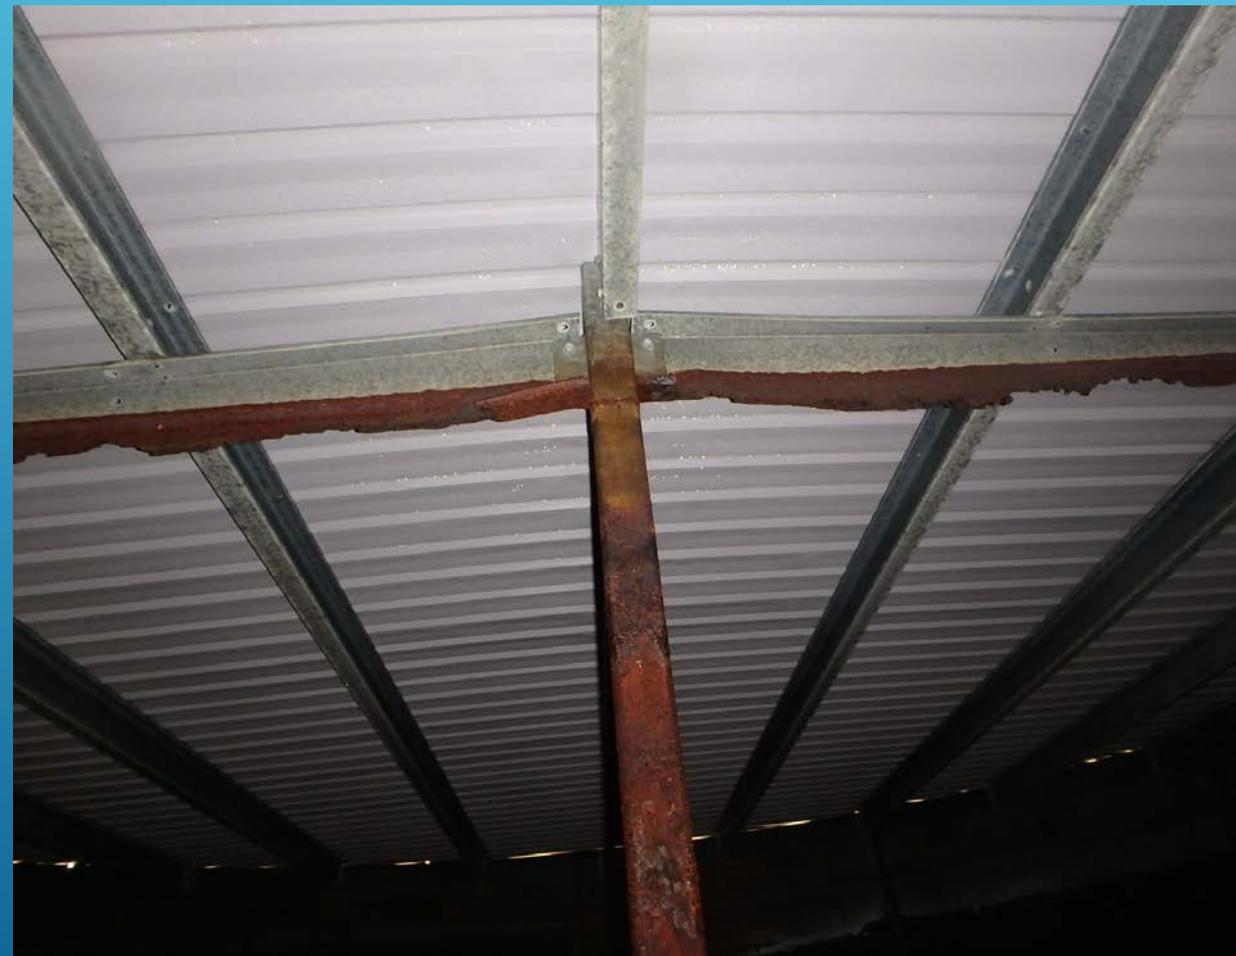
Zincalume purlins and rafters corrode heavily in warm, moist conditions. They are also quick to break down when immersed, if the tank water level settings are not adjusted correctly as the image on the RHS indicates

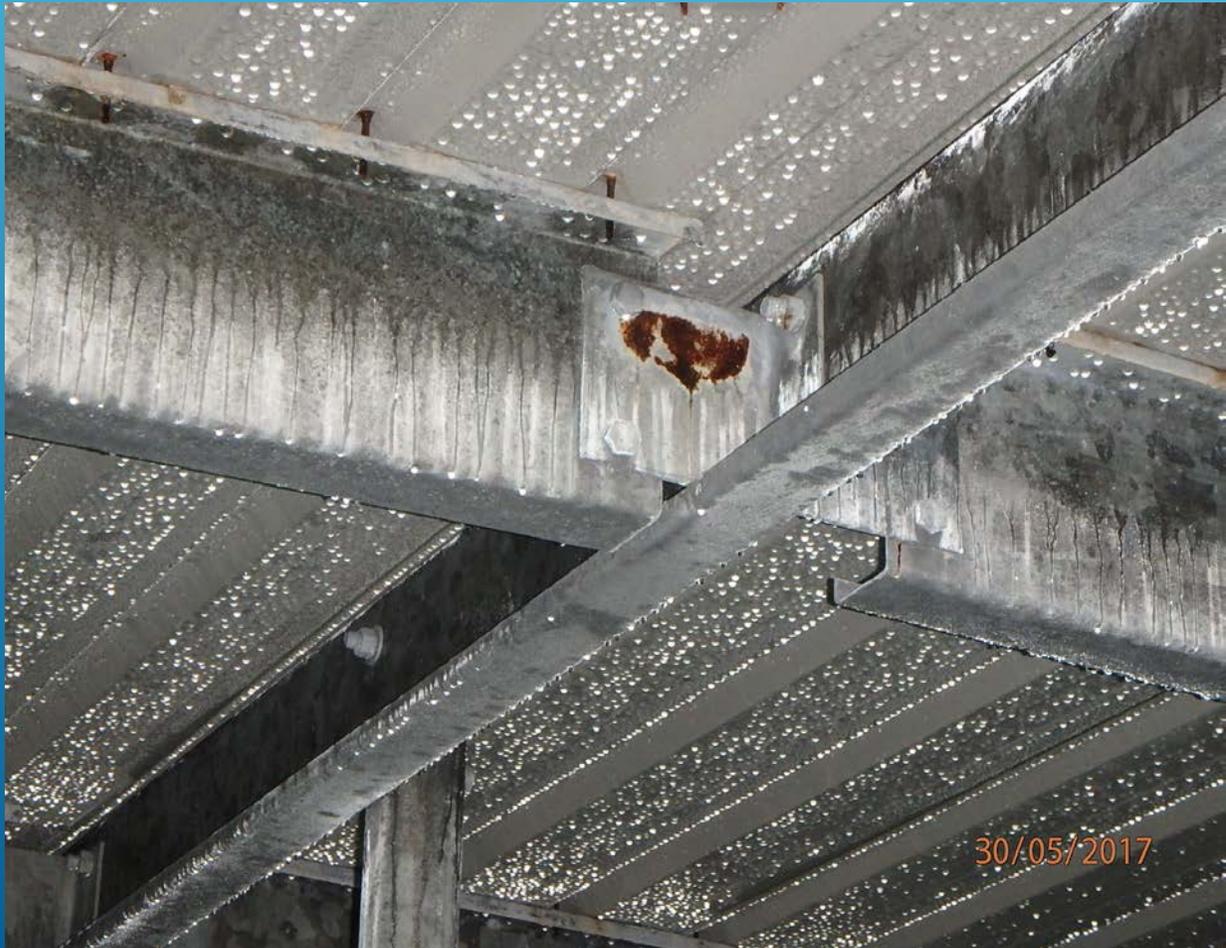
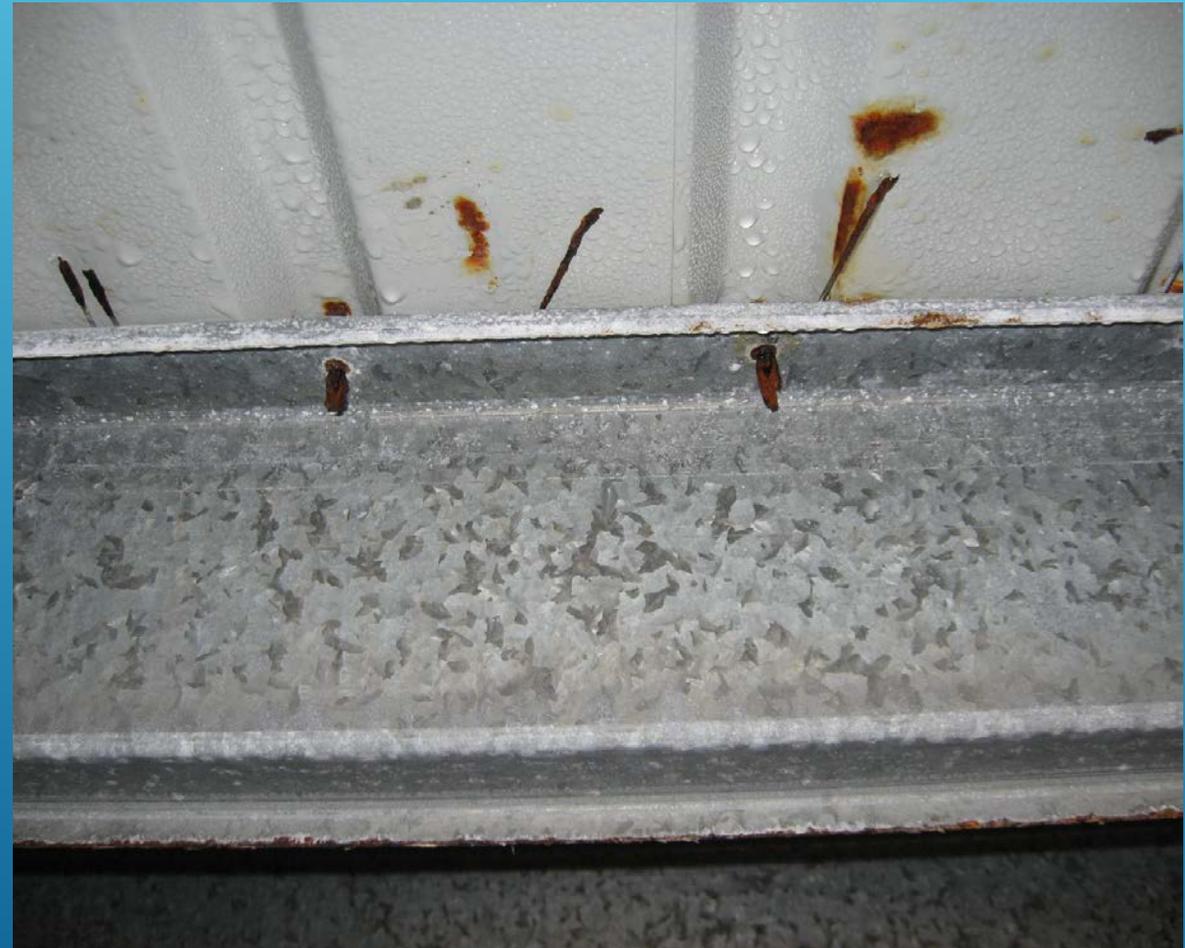
**Number 5:** Roof screws that are not rated for marine or extreme conditions. The roofing contractor often uses the cheapest type of screw to reduce costs, but corrosion failures are now occurring under five years in some environments.

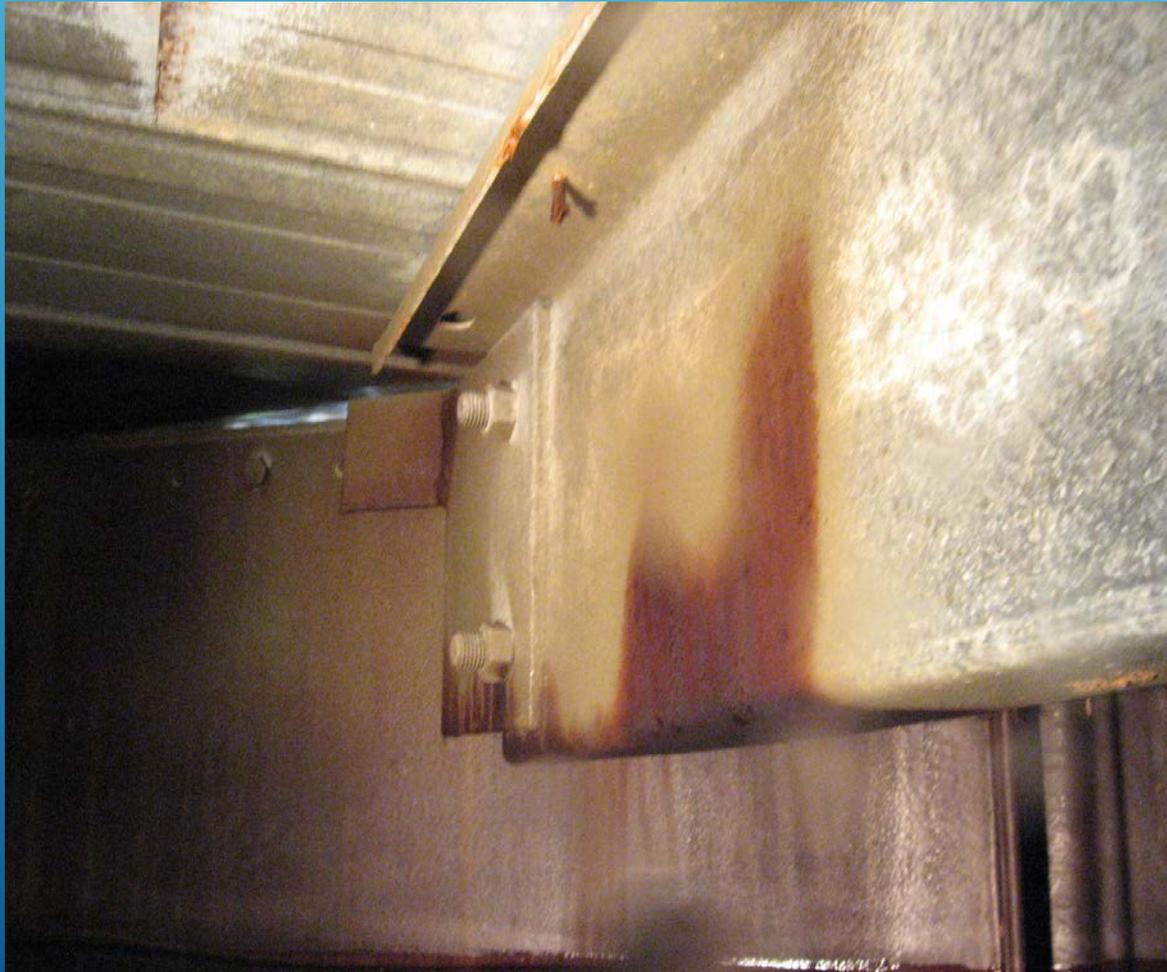
Cheap roof screws corrode away in warm, moist conditions. The roof sheets are then left unsecured as the image on the RHS indicates. Only category 4 Buildex type screws should be used in these conditions.

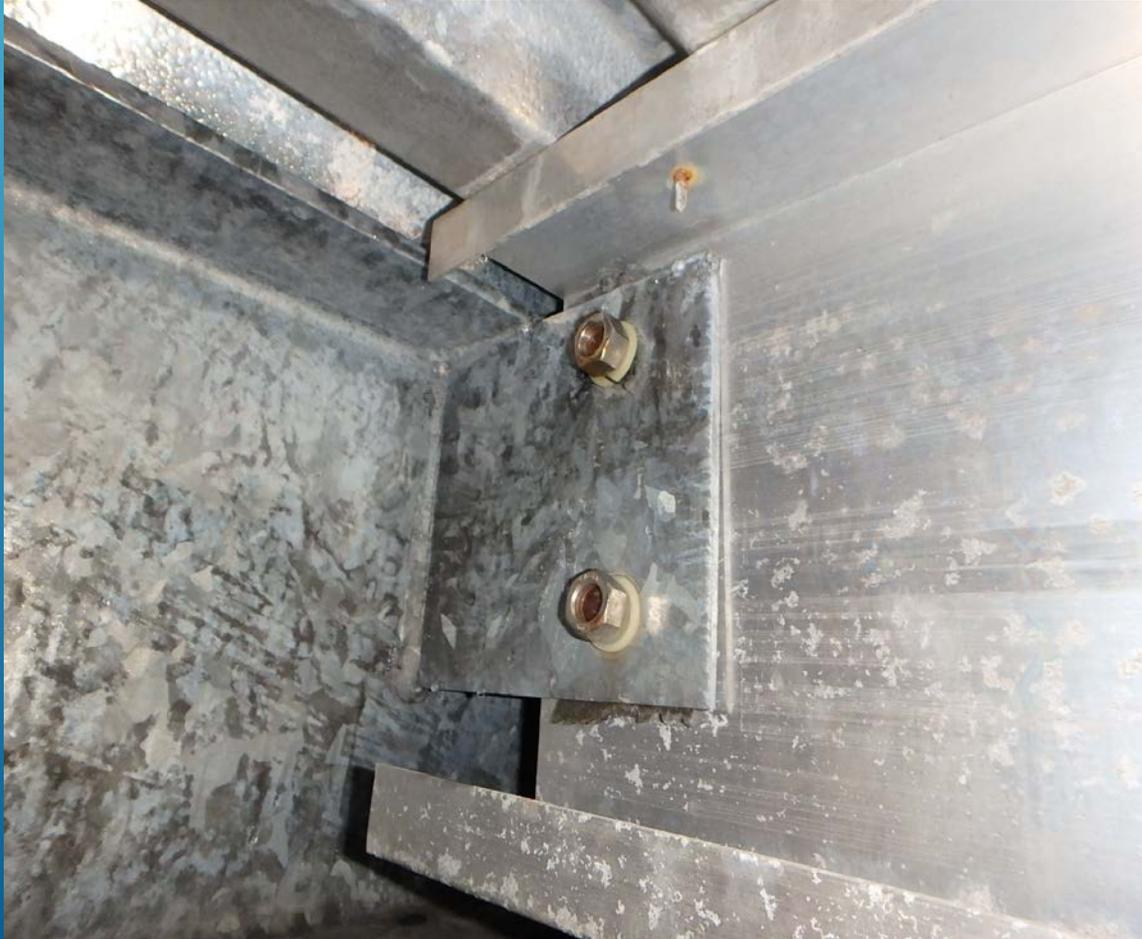
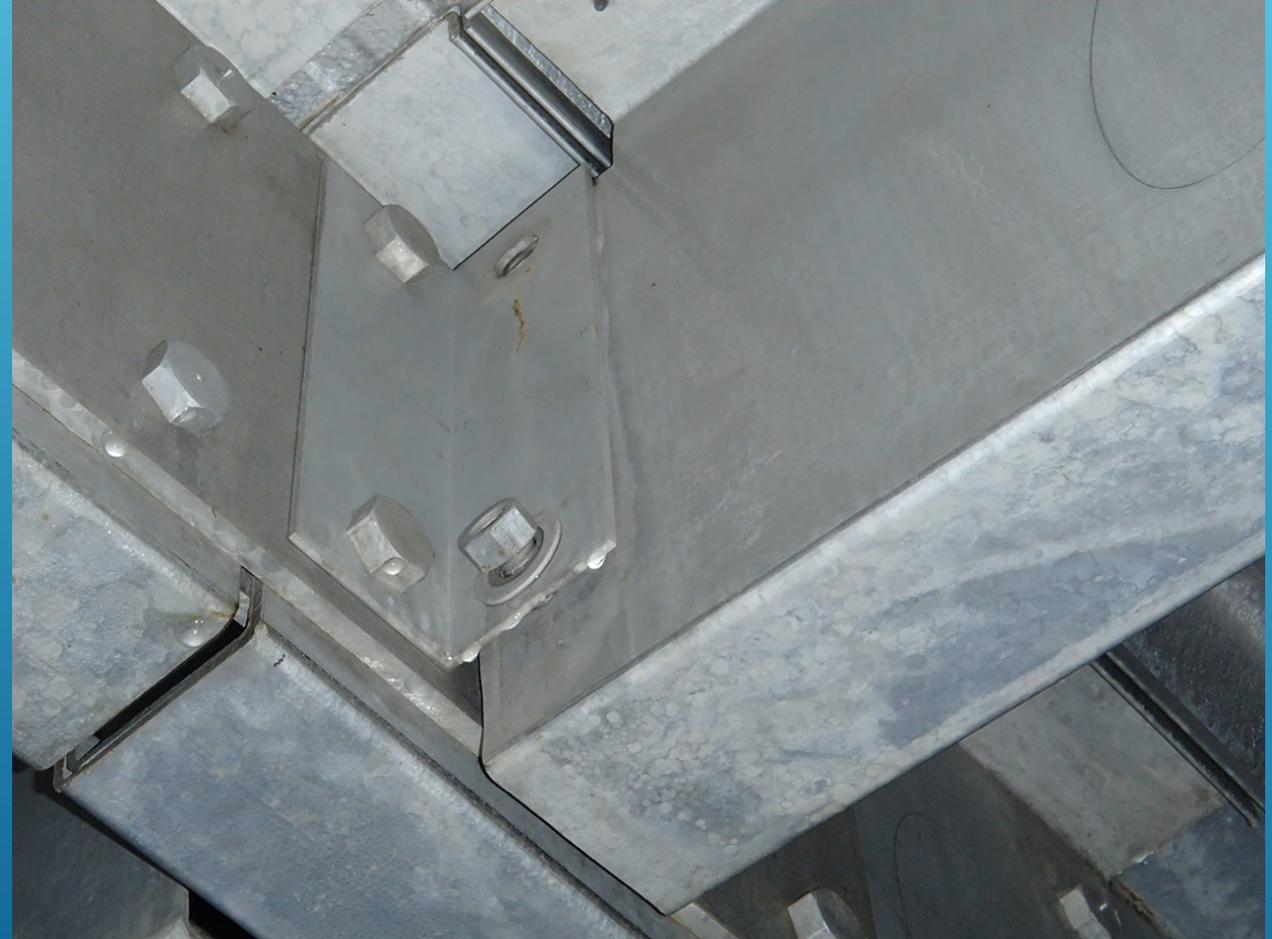
**No7:** Aluminum roof framing that is not securely fixed. While aluminum is a good corrosion resistant material, it has a lot of flexing movement and will loosen off the fixing bolts unless nylock type nuts are used. Being a softer material to steel, extra thickness is also required for edge flashings, as fixing screws are prone to pulling out in windy conditions.

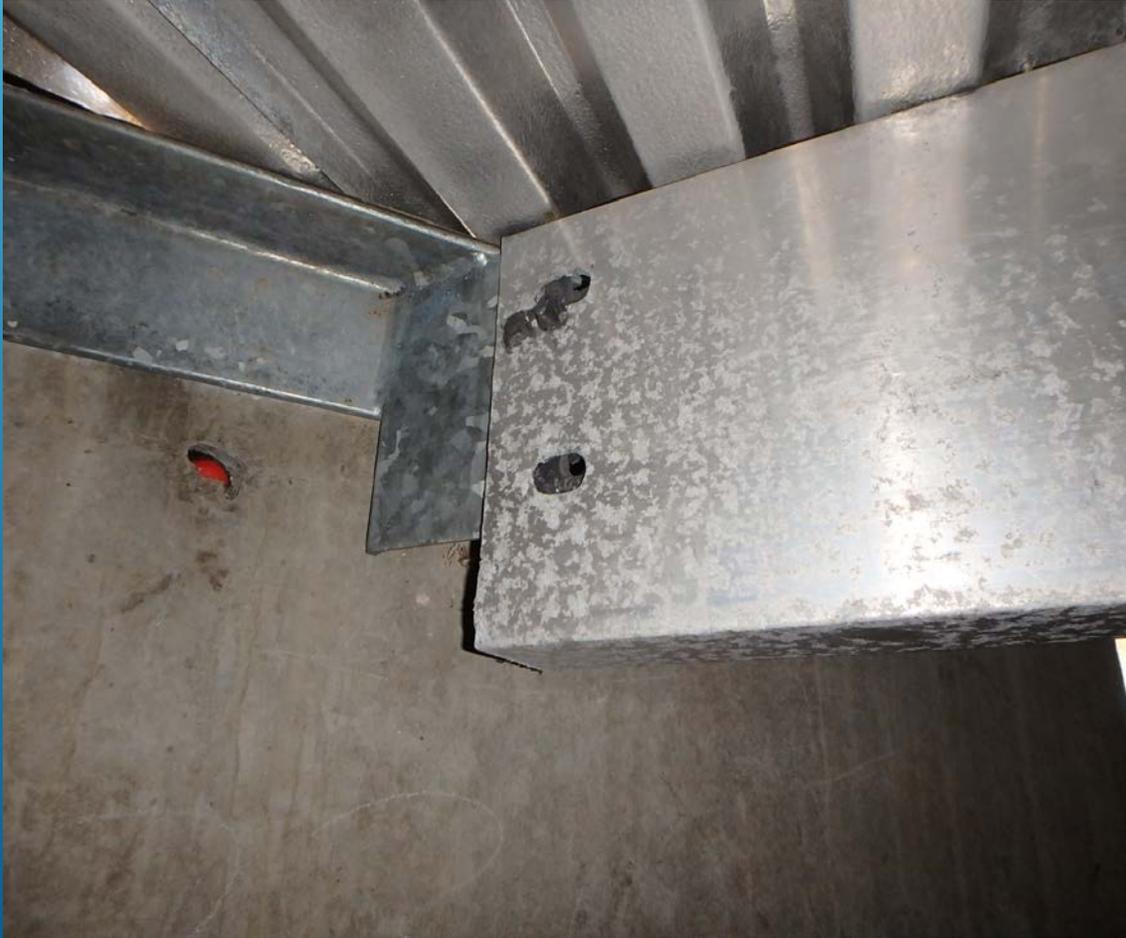
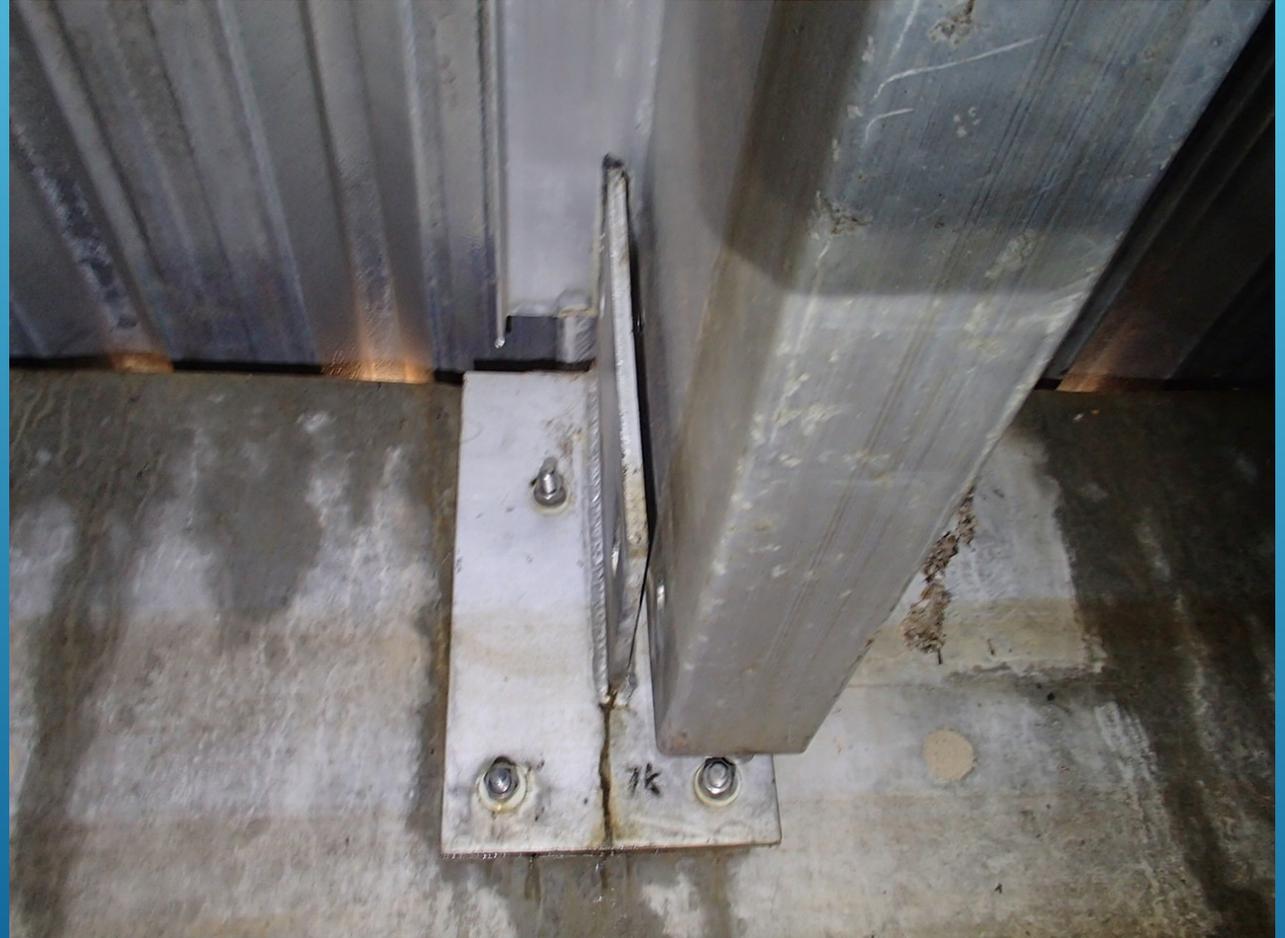
Connection bolts are missing completely in some areas.

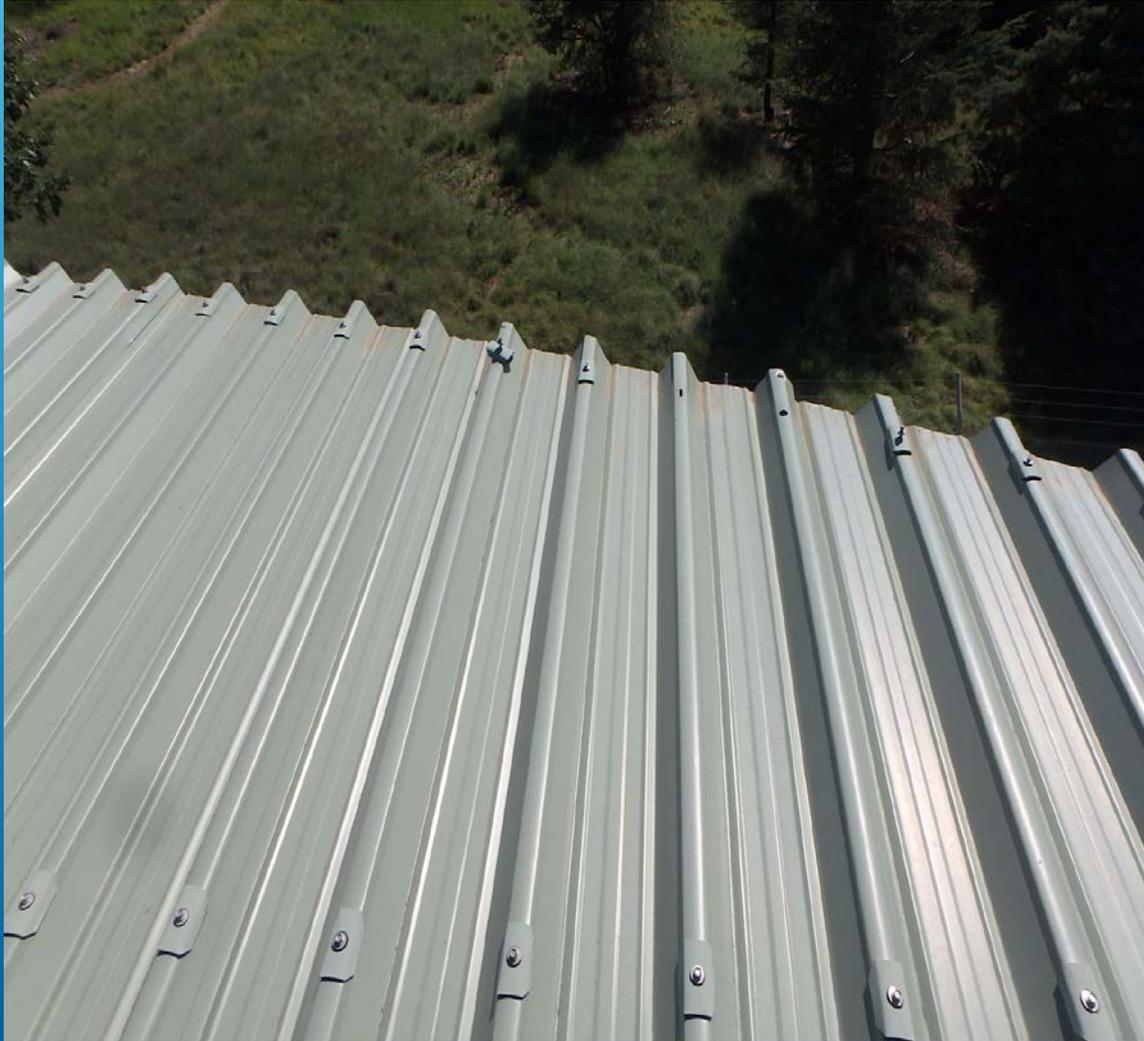
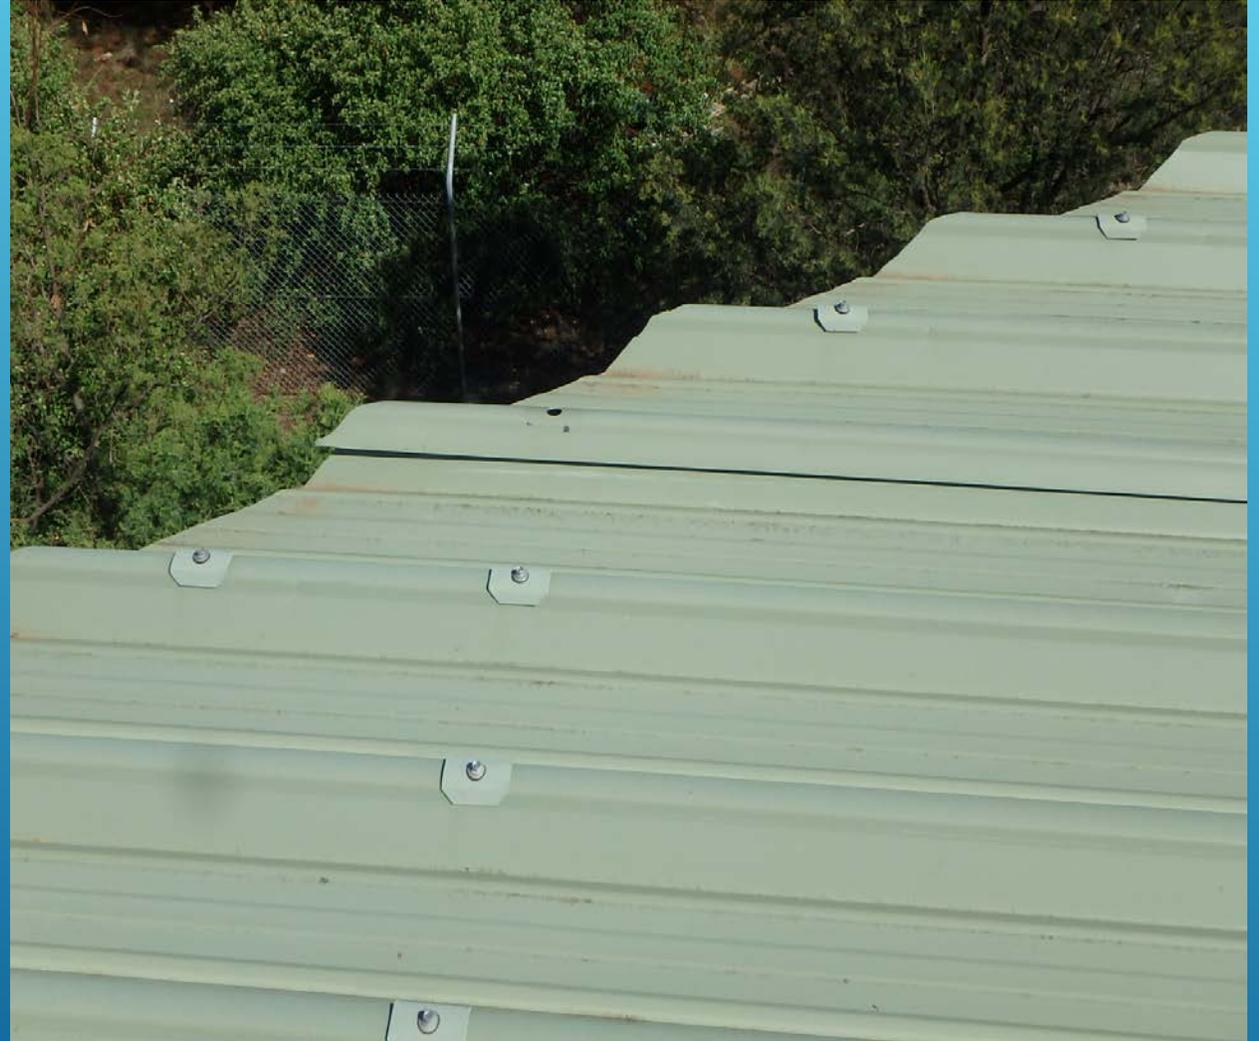
Roof edge screws fixed into thin aluminum fascia's, pull out in areas of high wind loadings.

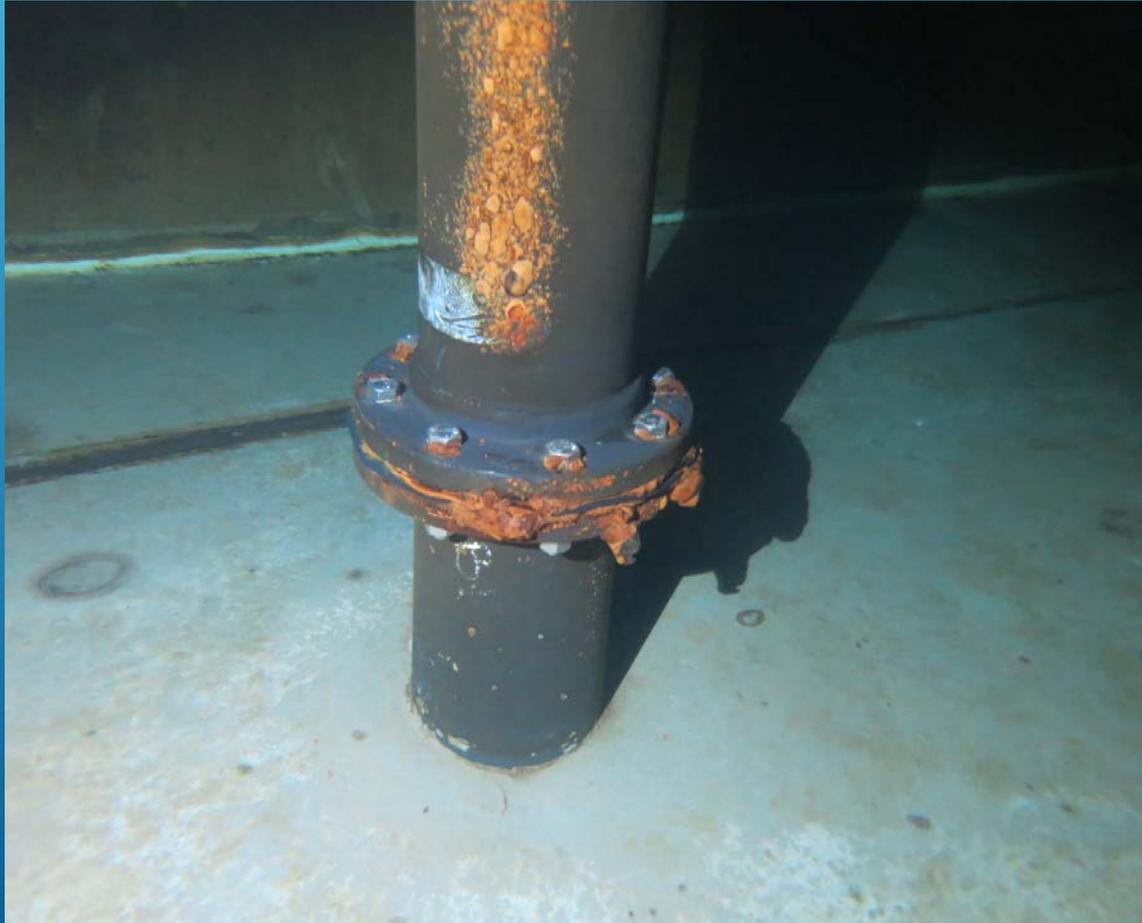
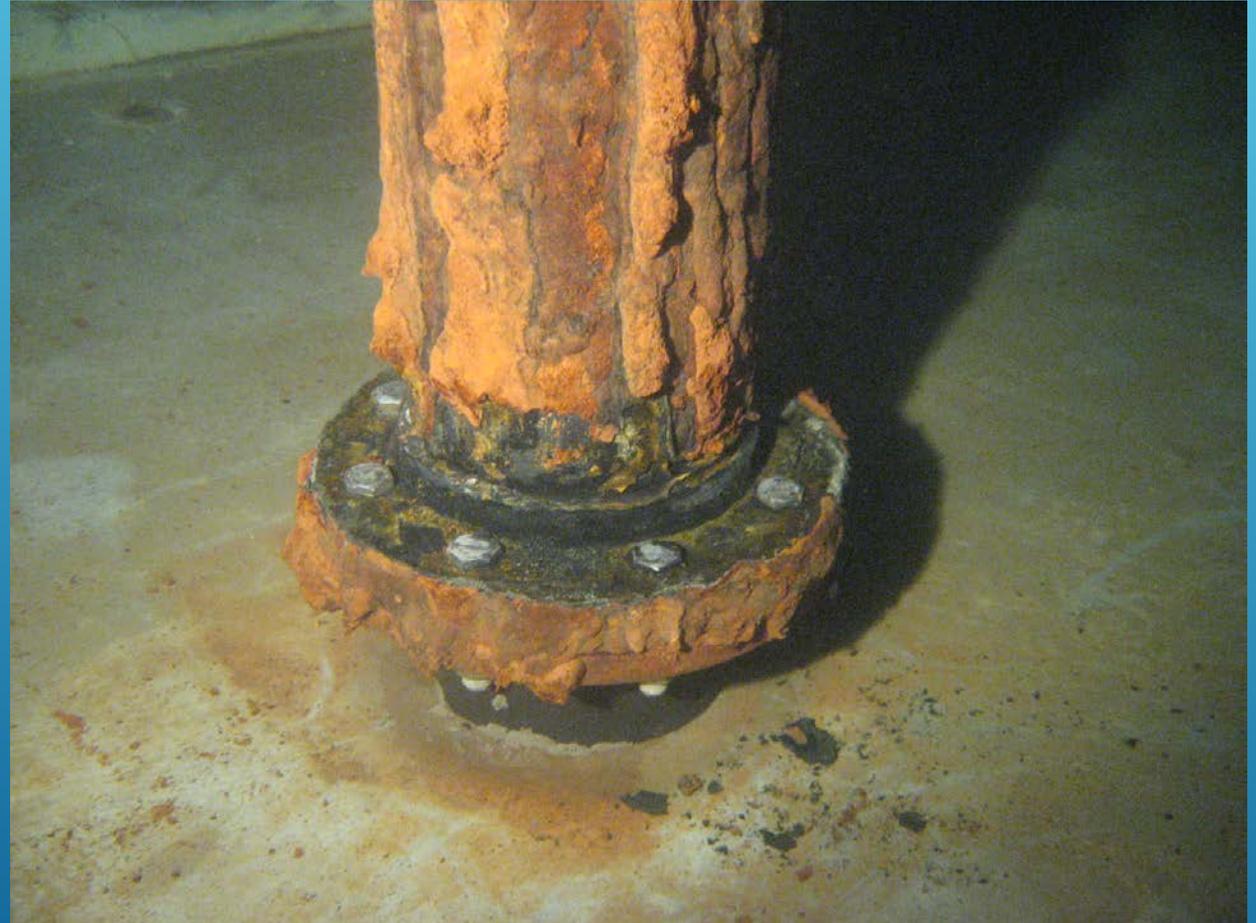
**Number 8:** Internal pipework and other fixture materials that are not suitable for constant immersion. Concrete tanks often have ductile iron pipework that is uncoated and this leads to accelerated corrosion. Fixing bolts and supporting brackets are often not insulated or are made from dissimilar metals, which will also contribute to corrosion issues.

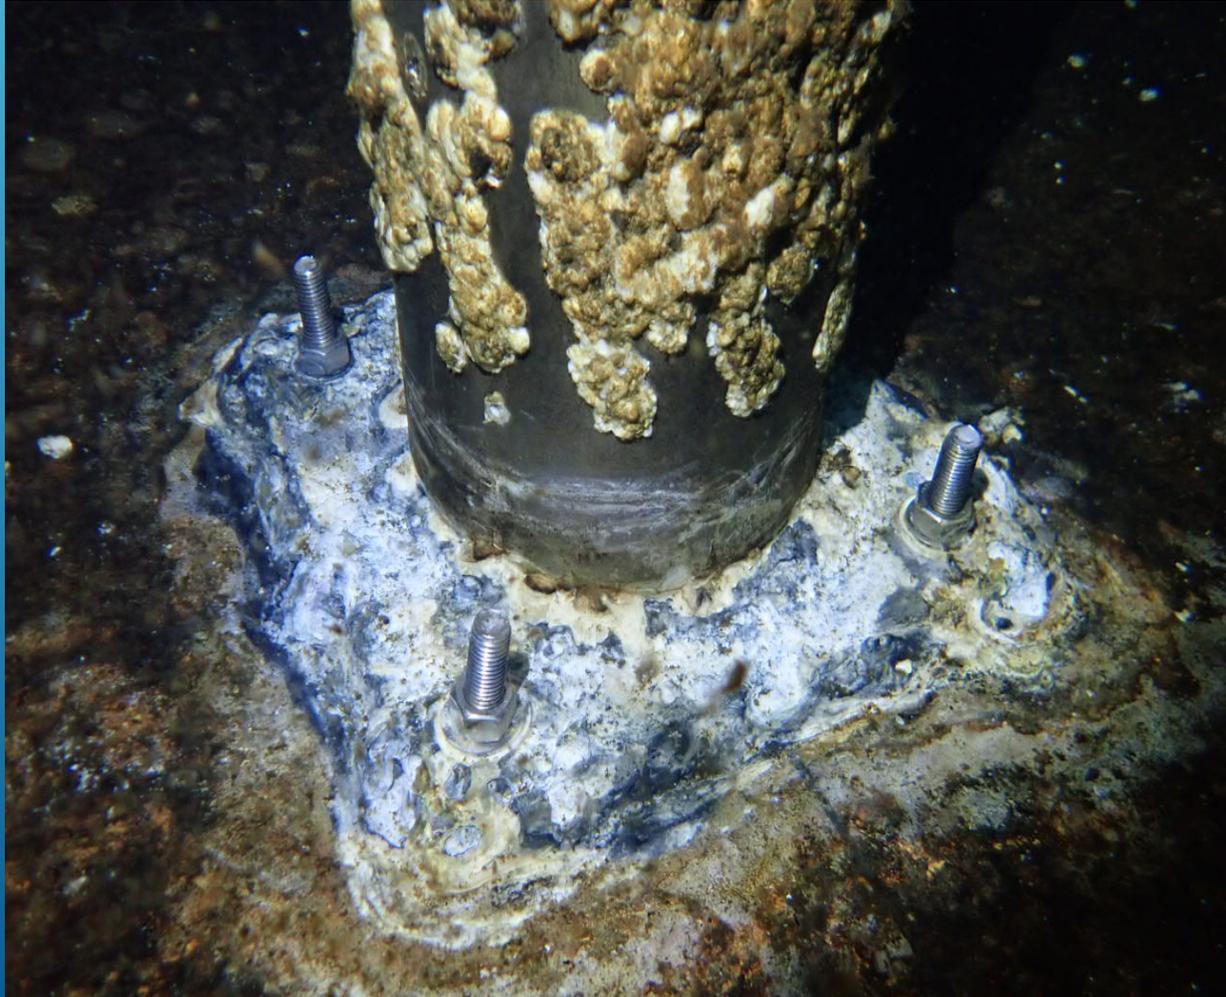
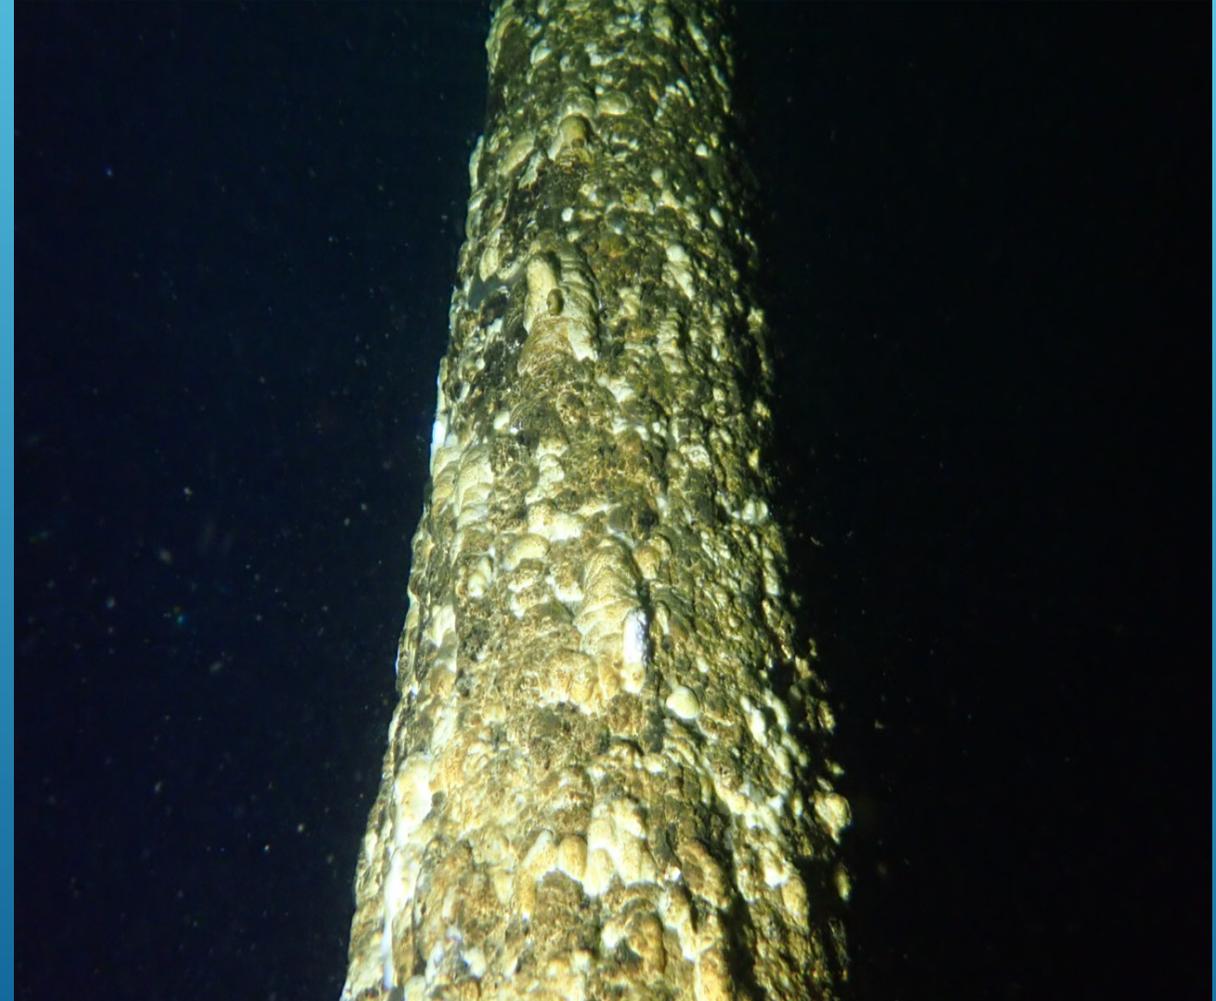
Aluminum posts corrode quickly in some waters, depending on pH levels. The SS bolts also contribute to the aluminum deteriorating. Another factor is the posts not being isolated from the floor fixings and roof framing, as they quickly become an anode to protect the reinforcing steel in the concrete walls and floor.

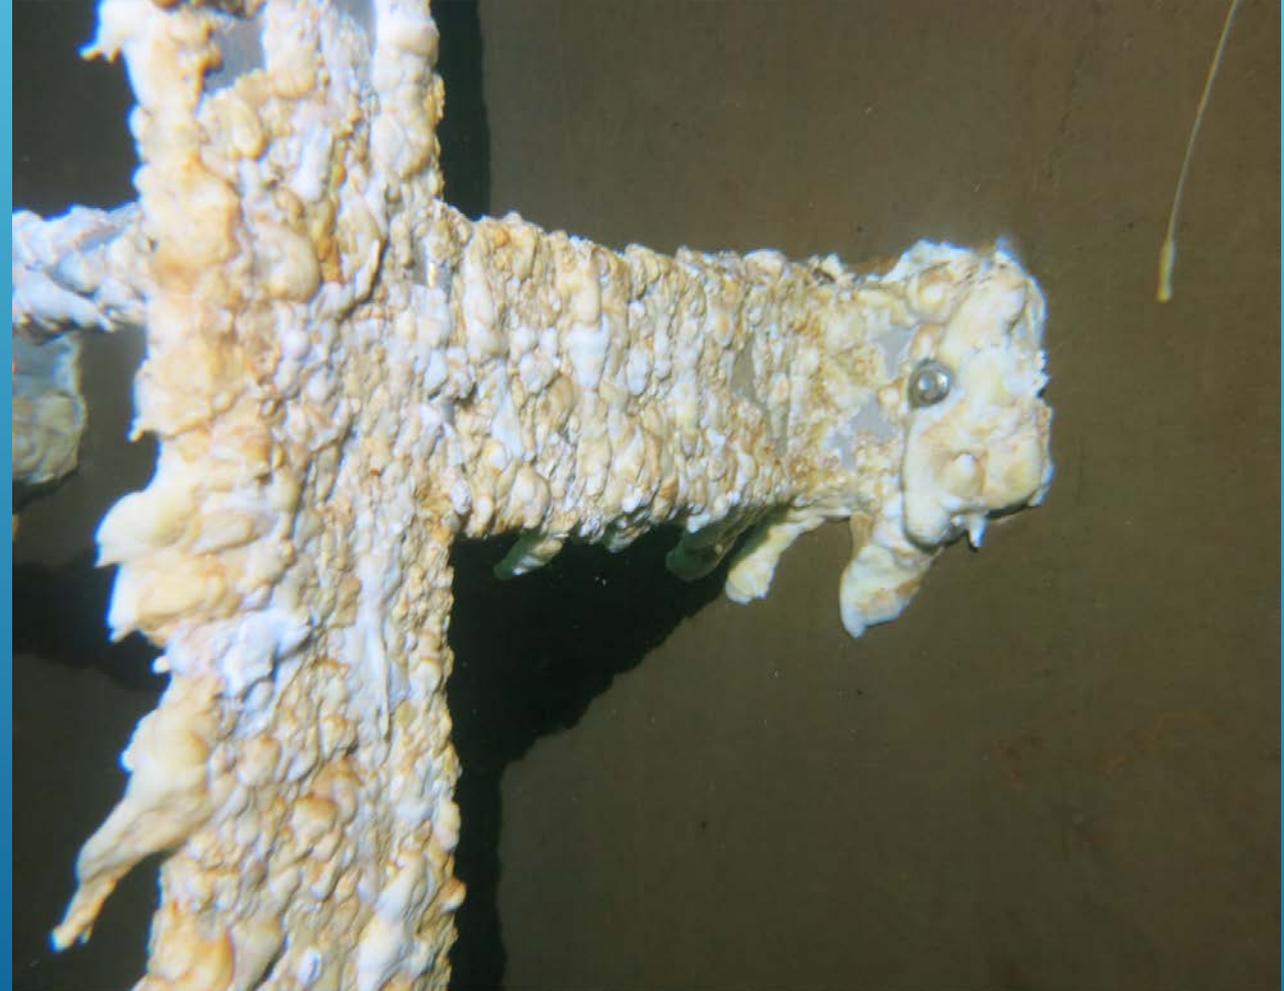
Aluminum ladders corrode quickly in some waters, depending on pH levels. The SS bolts also contribute to the aluminum deteriorating.
