## **Unsuitable Outcomes Top 10 – and still counting:**

There appears to be a new mentality of cut and paste design occurring in our current reservoir constructions. Old mistakes, unsuitable materials and poor building methods seem to be reappearing again, after a period of relatively good outcomes.

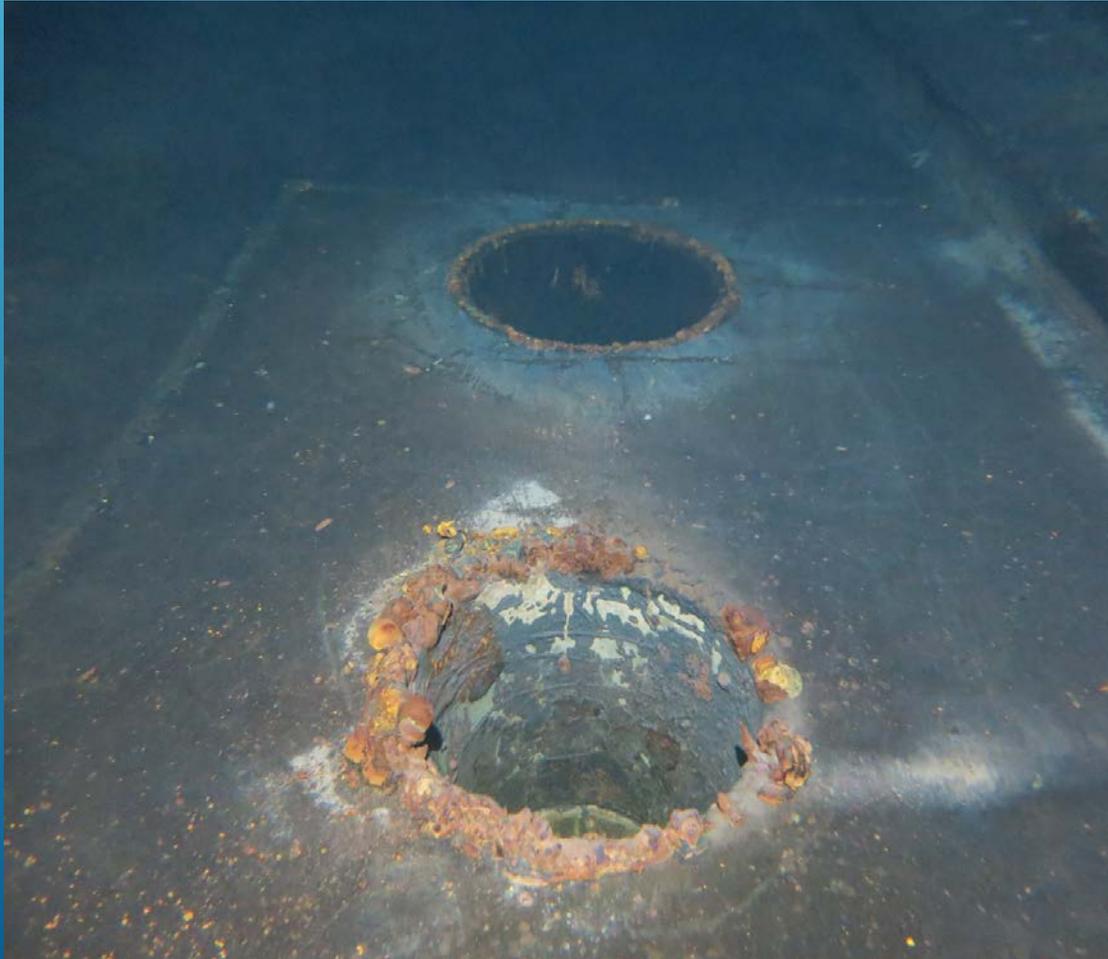
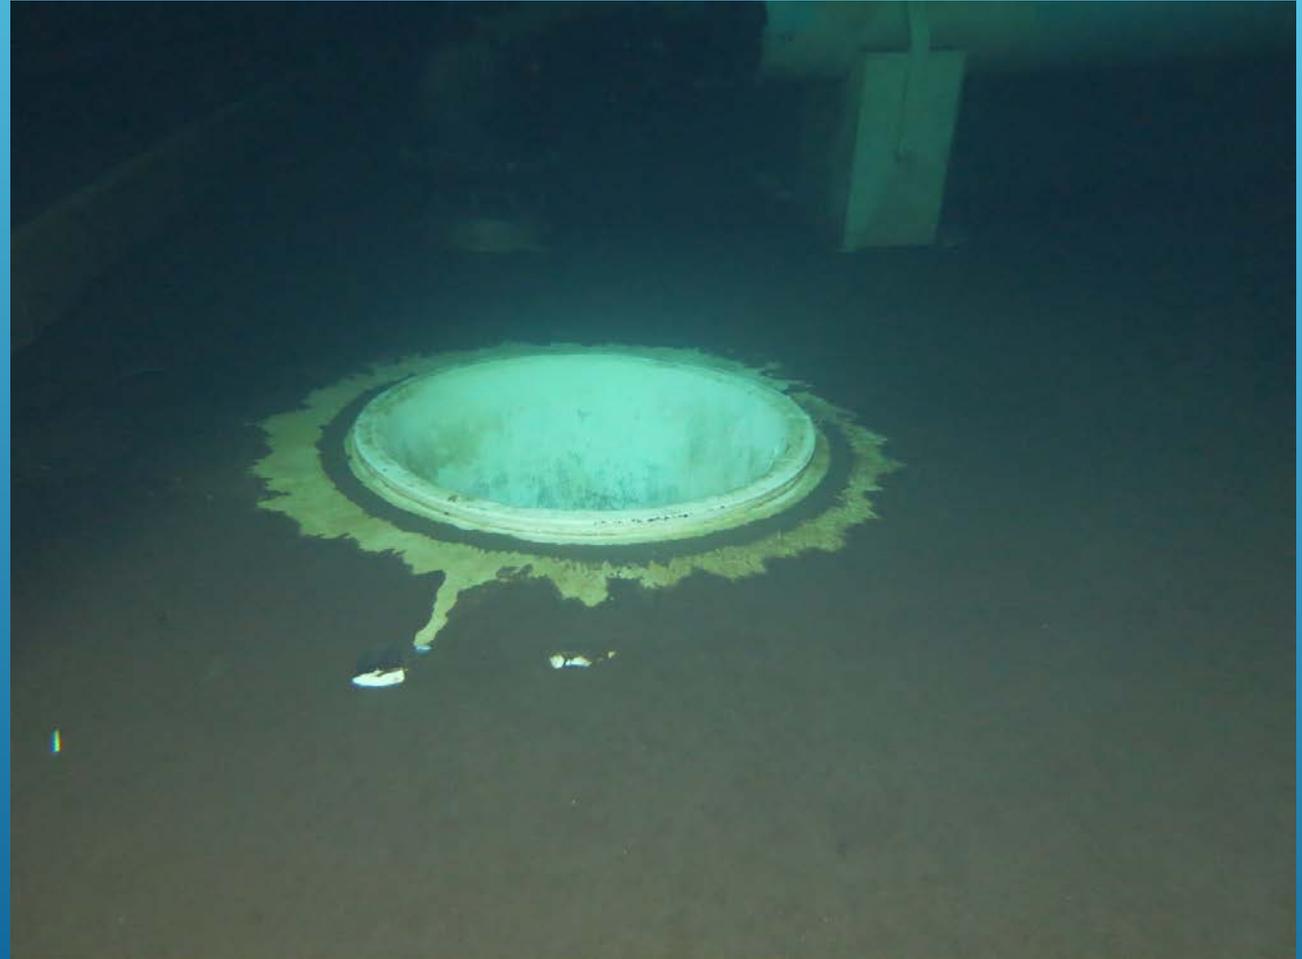
**Number 9:** Not thinking about how internal pipework will affect the stored water quality. Inlets placed next to outlets lead to short circuiting issues. Outlets close to the floor allow sediments to be drawn into the downstream reticulation system. Scours not being fitted in the lowest area of the wall or floor will not allow for effective draining of the tank.

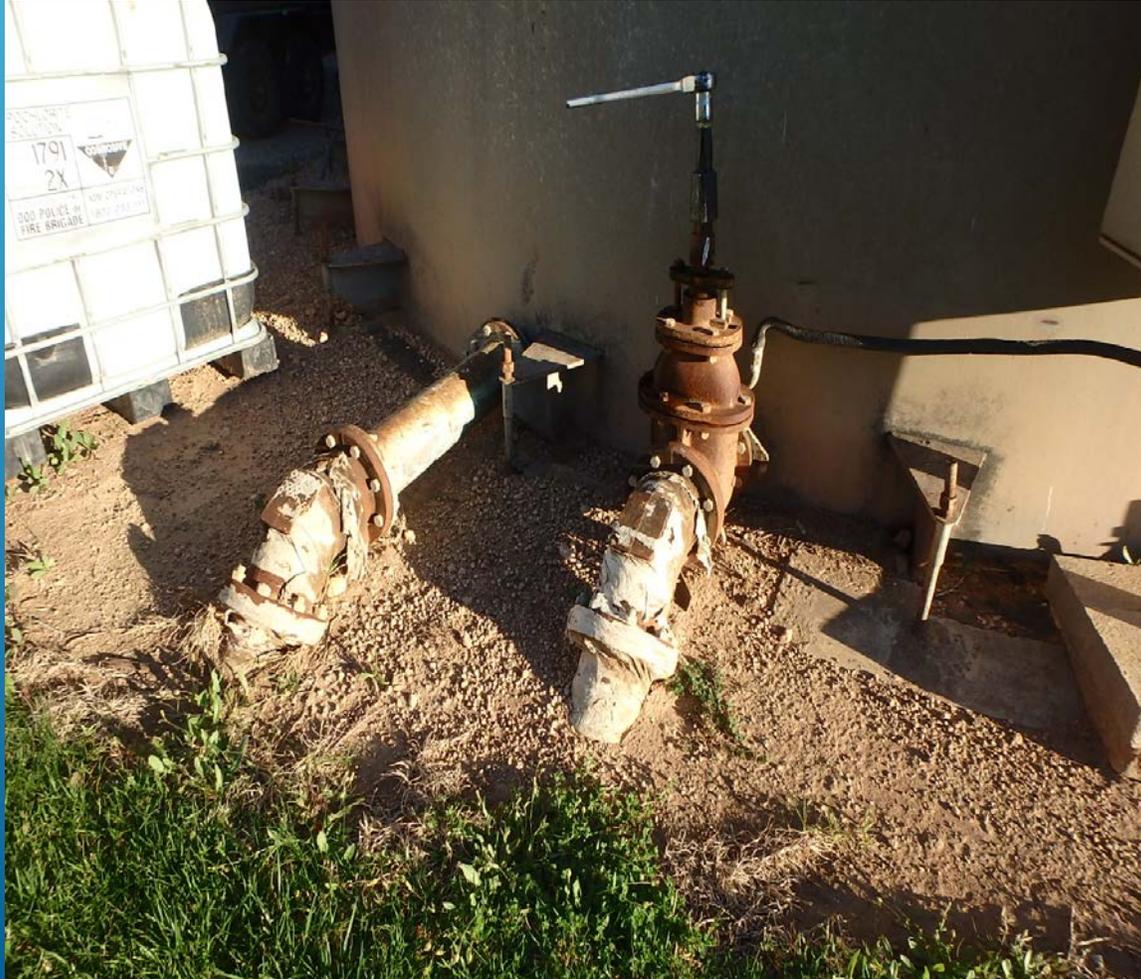
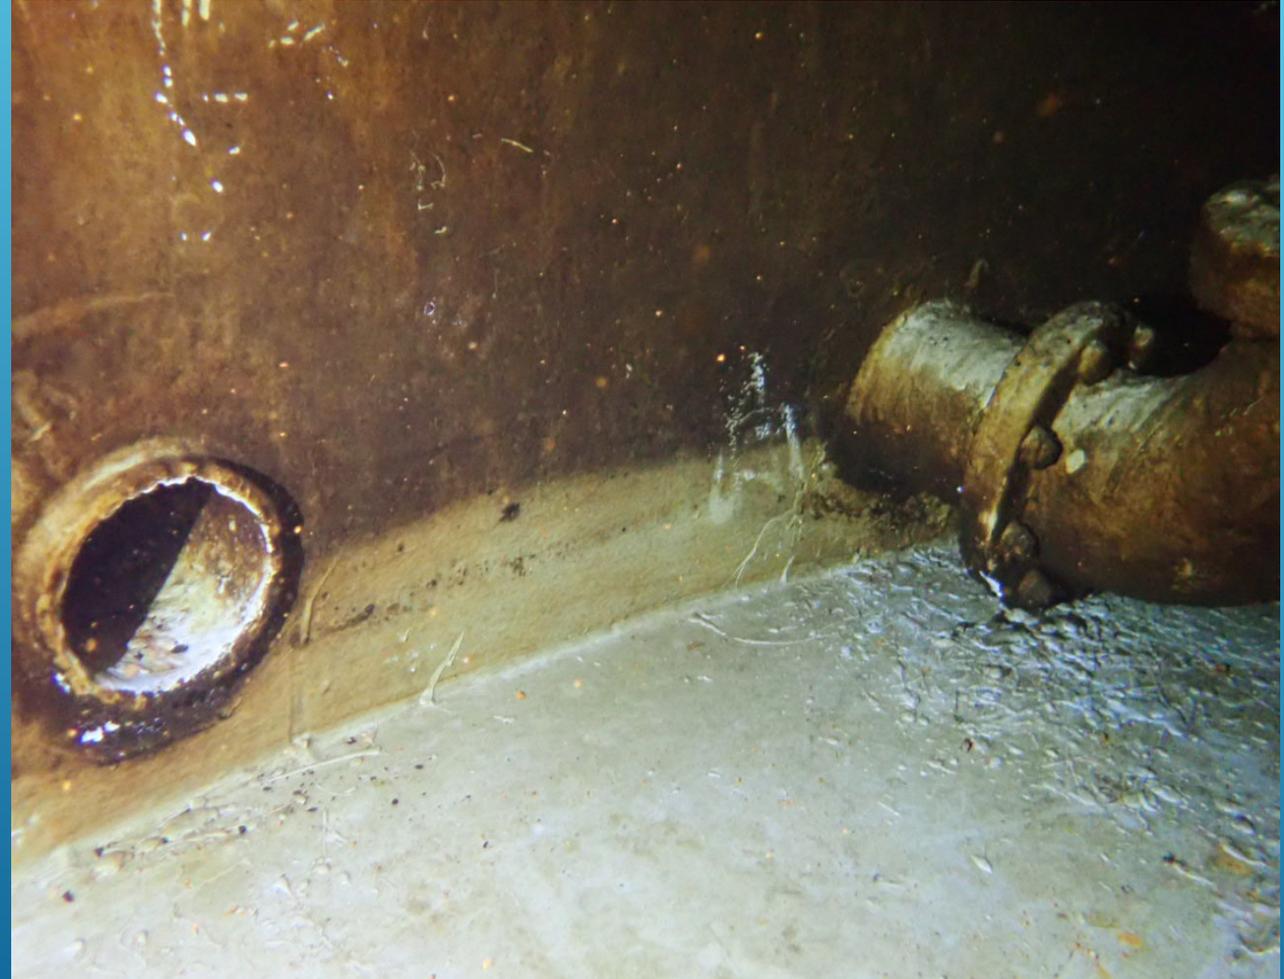
The scour penetration is 120mm up off the floor area, which makes it impossible to fully drain the tank.

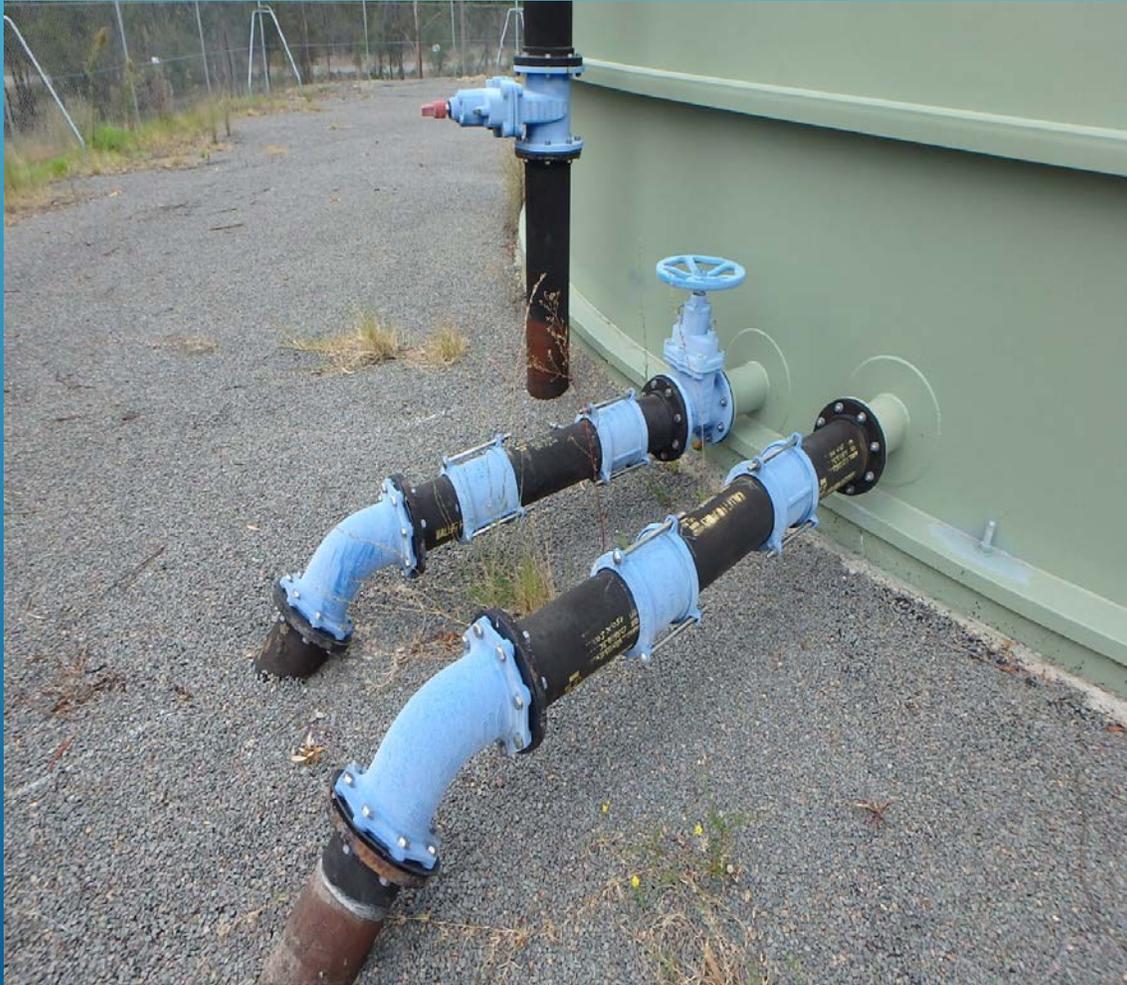
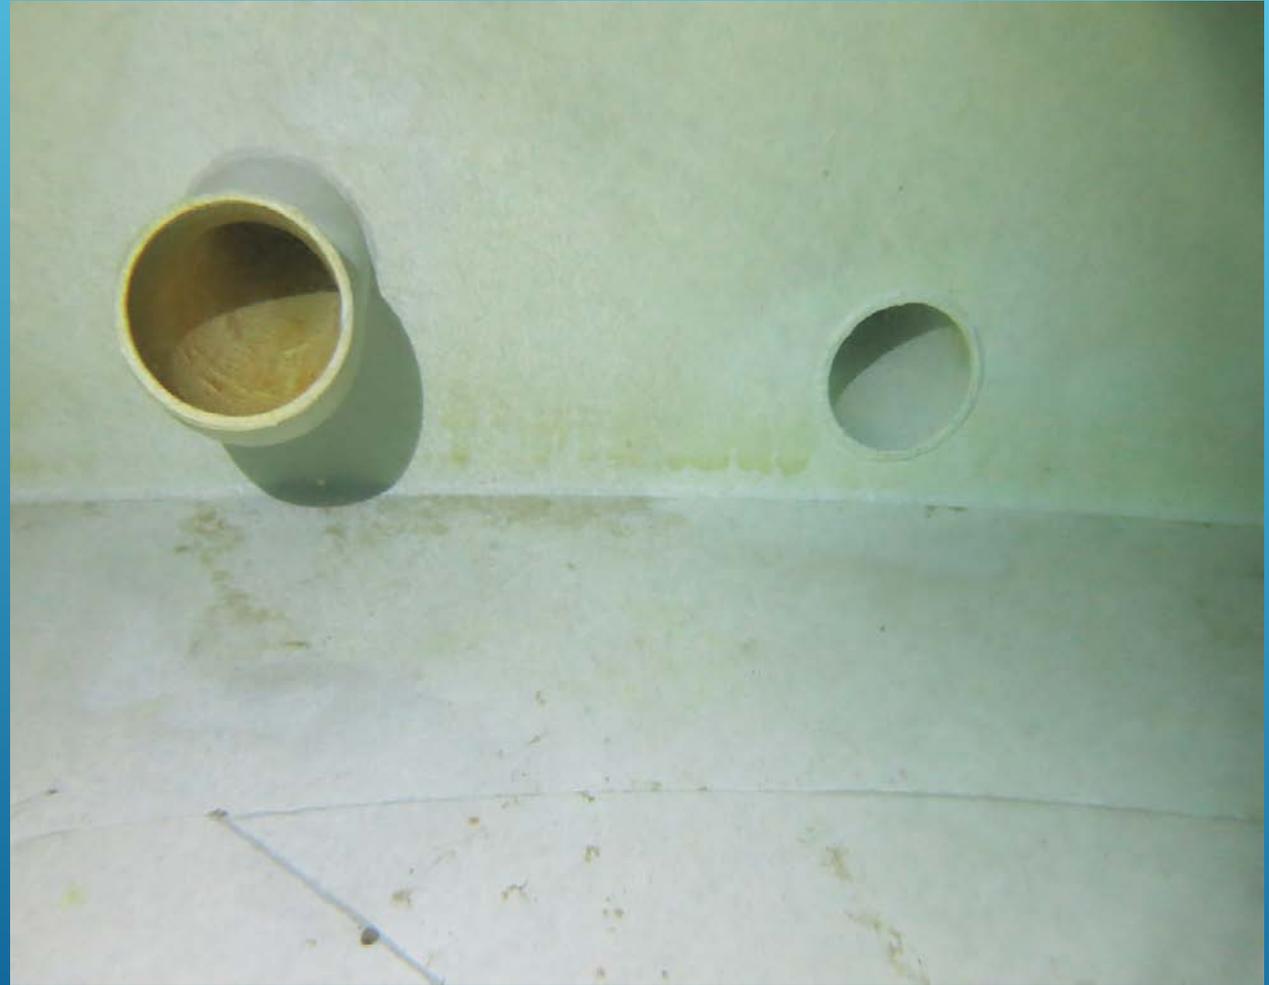
The scour penetration is 80mm up off the floor area, which makes it impossible to fully drain the tank. This is a new tank, so cut and paste must have occurred in the design.

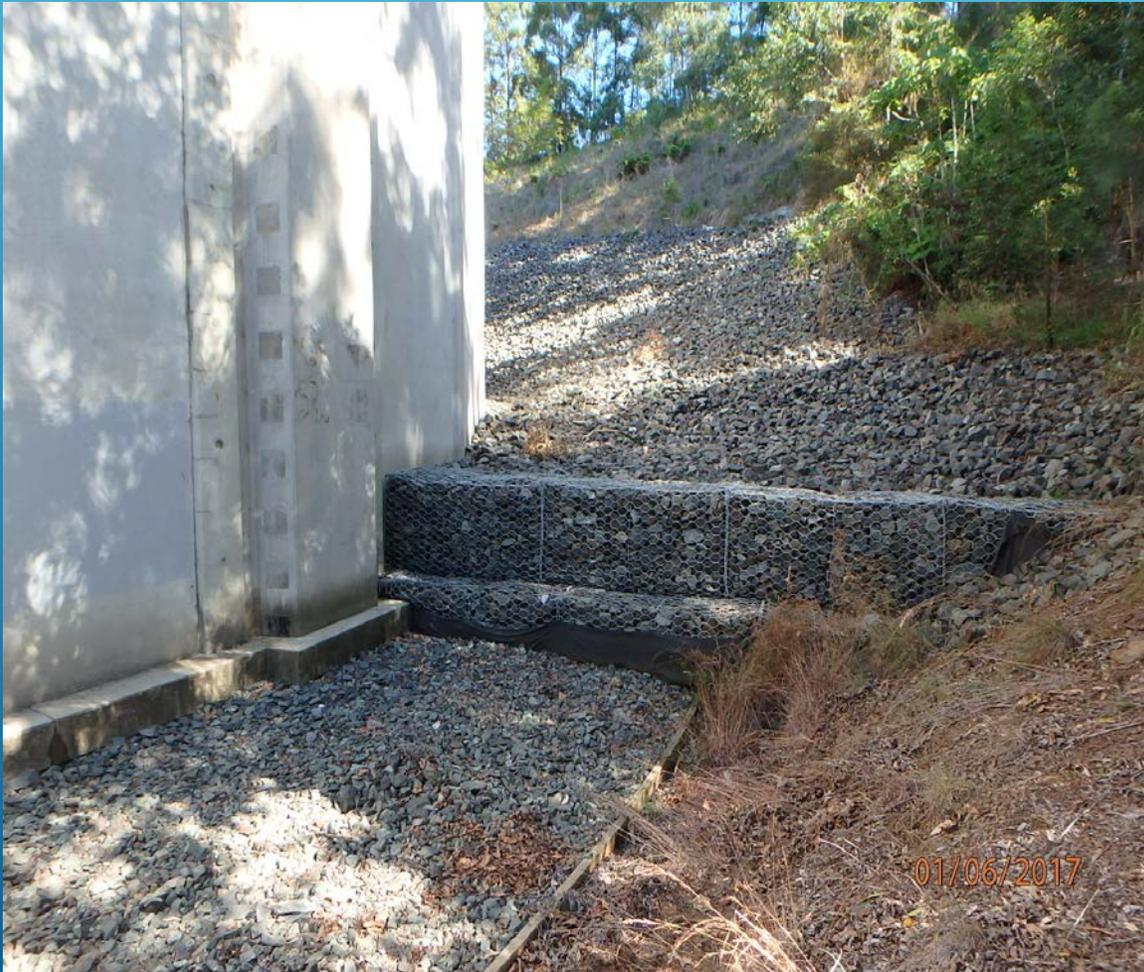
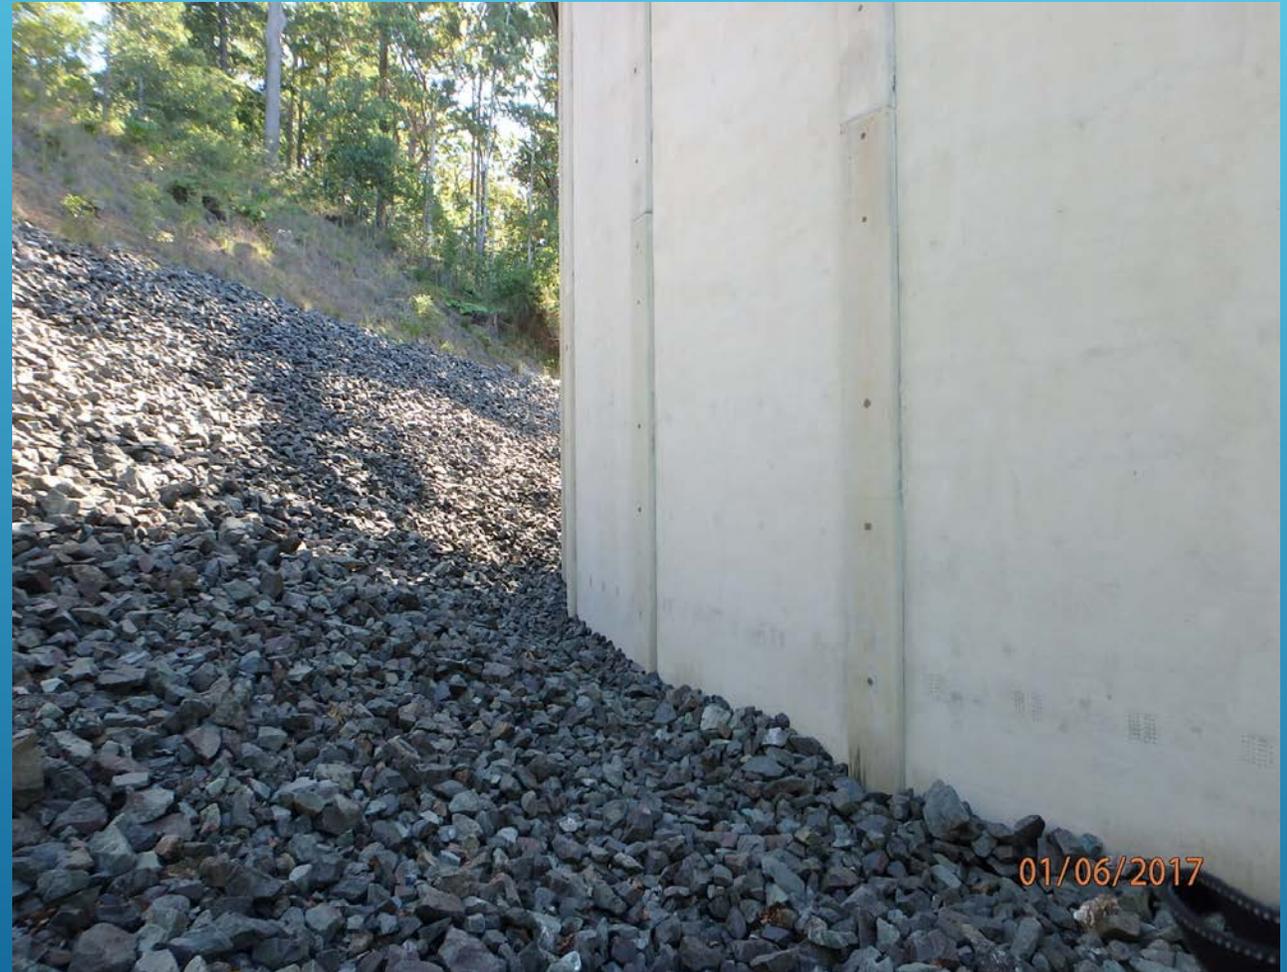
**Number 10:** Building a tank whose walls are designed to move in and out under pressure and then the client back-filling directly against those walls, to save money on a retaining wall. This leads to significant structural damage and a complete failure of the tank in some circumstances.

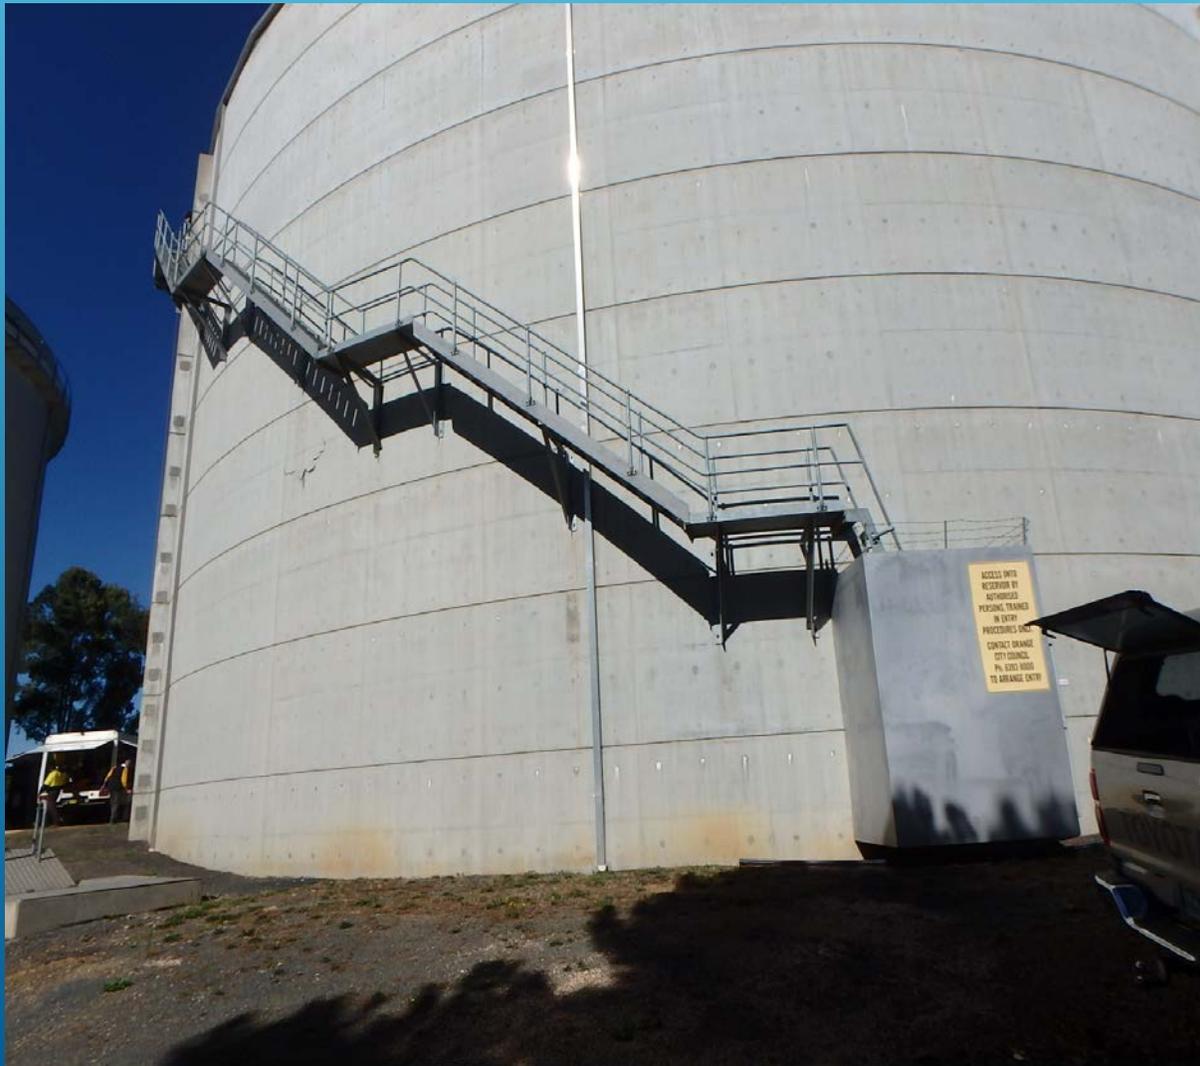
The backfilling has caused the walls on this tank to spall in the middle areas, after three years in service.

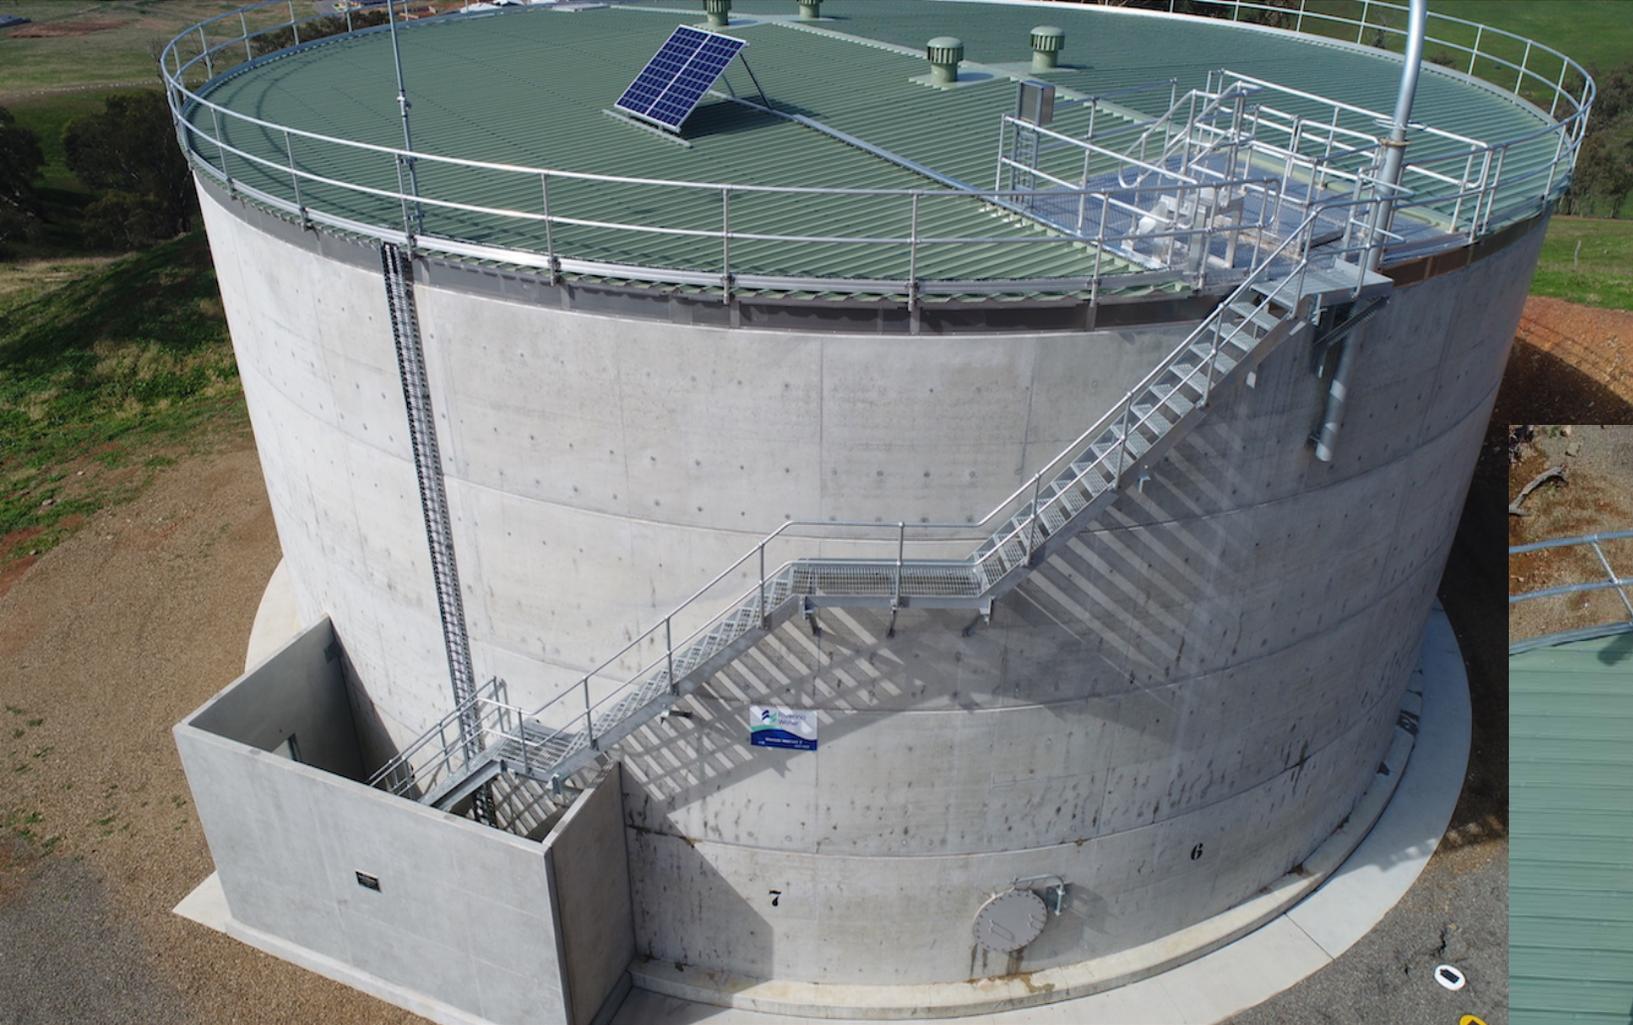
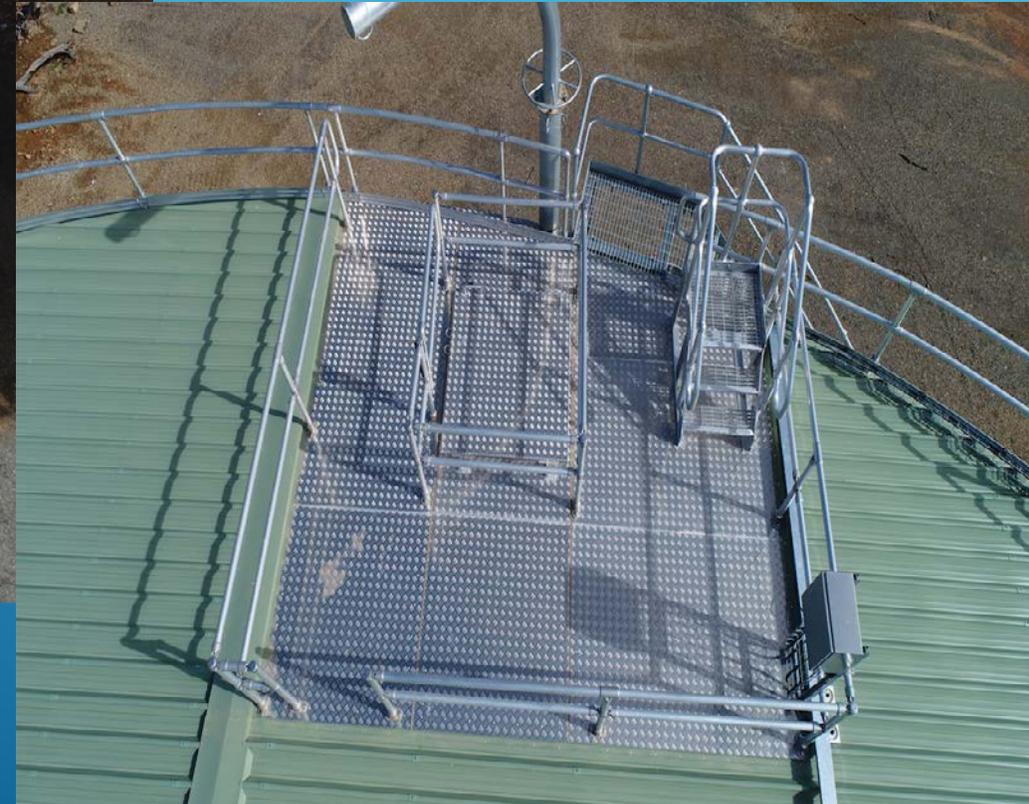
The following images show a tank design that has not allowed for the most basic of maintenance requirements – regular cleaning of sediments. The external ladder system runs in the wrong direction, so that the platform area is directly above the inlet and outlet pipework, instead of the scour penetration. This means a diver runs the risk of lowering his gear down over the outlet and then having to walk a distance around through the accumulated sediment to access the scour penetration. It also has an excess of safety rails around the platform that clutter up the working area without providing any additional benefits to workers performance outcomes.

The scour penetration is @ 9 o'clock, where the ladder enclosure begins. The design should have been reversed 180 degrees so that the enclosure was at 6 o'clock and the platform @ 9 o'clock.

There are too many unnecessary handrails around the entry hatch and platform areas.
