## Disinfection System Management

# Covered Storage Tanks.

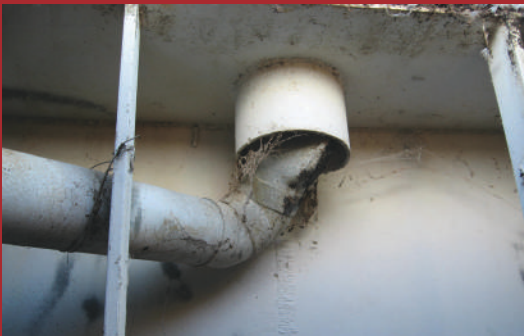
Faulty drainage points are the largest contributors to 'unseen' contamination – often the whole roof area keeps on draining back into the tank, along with the surface contaminants that have accumulated upon it.

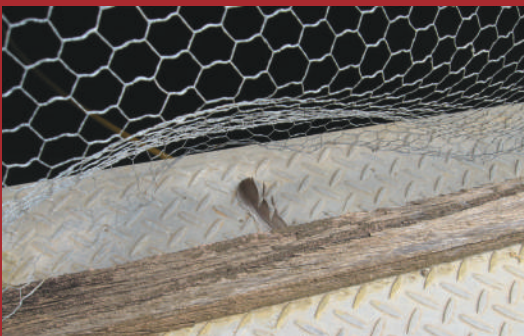
Roof structures can also provide a safe haven for small birds and vermin, who would otherwise be preyed upon by larger natural predators, if they remained in an open environment. Any gutter system that drains internally needs to be fully checked for integrity and ventilation areas need to be checked for vermin or bird entry potentials. Only then can a covered storage tank be considered 'an improvement' upon the original open design.

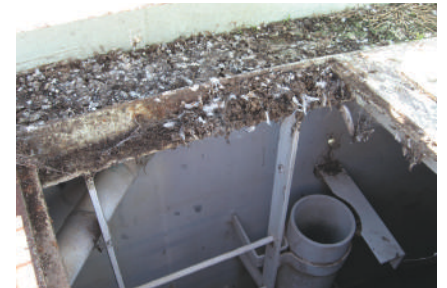
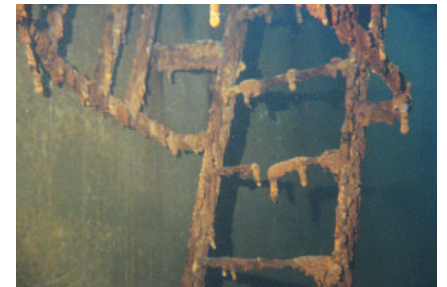
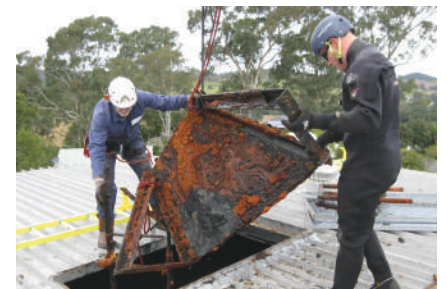
Storage tanks need to be assessed for contamination entry points and any internal materials that can degrade and affect water quality. Corroded metal ladders and pipework are common and these are large consumers of disinfection chemicals.
