## SA Water Condition Assessment Program

# Contamination and the GST Principle

# Under-roof Condition Assessments

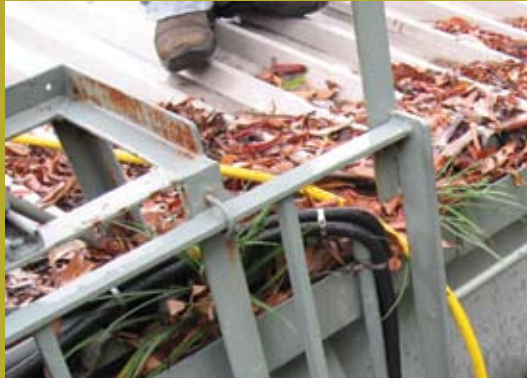
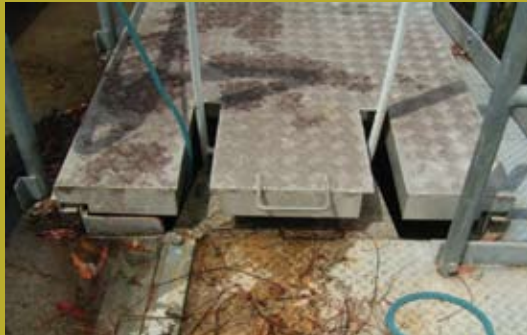
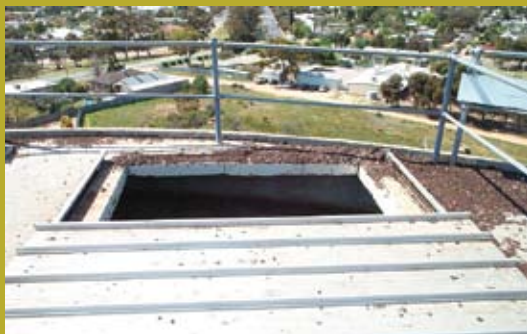
**Many water storage tanks have poorly designed access areas – a balance needs to be achieved between personnel safety and water quality.**

Great importance has been placed on eliminating 'trip hazards' around entry hatch areas – the downside is that all sorts of contamination accumulated around the surrounding areas are free to drain into the tank, and this directly affects water quality.

Clients and designers should apply the GST principle (grain silo test) to all water storages – grain silos and water tanks are very similar in structure and design, however grain storages have to be one hundred percent free of water and debris contamination to avoid spoiling the produce inside.

Why is it acceptable that storm water, bird faeces and leaf debris can freely enter our water storages? Our drinking water also needs to be 100 percent free of any form of contaminant that will adversely affect its quality.

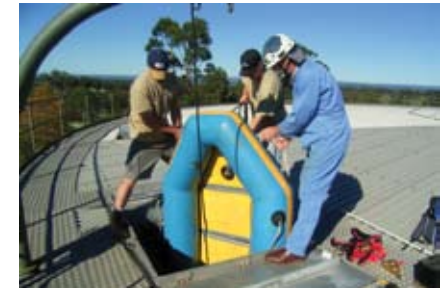
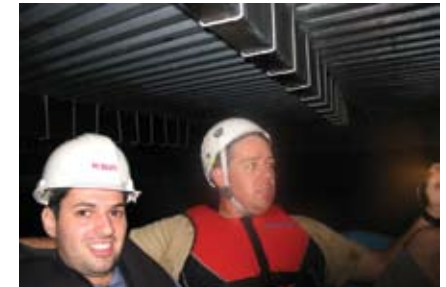
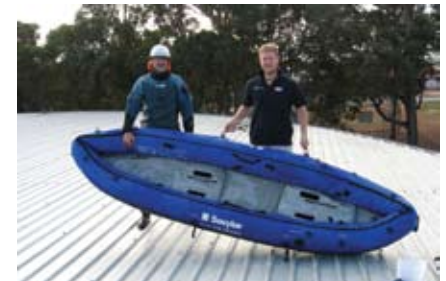
Aqualift provide the safety, access and support to take engineering staff inside tanks for detailed structural assessments of the roofing and upper wall areas.

Several types of inflatable boat are used, depending on the hatch sizes available – our canoe is very compact for tighter areas and it can be inflated after entry into the tank by an operator wearing a dry suit.

Tanks are filled to 90/95 percent capacity to provide close access to the structural members and connections of the roof framing and wall areas – laminated plans can be carried in the boat and marked accordingly, for later transfer during the report writing process.

A battery powered outboard motor is used to manoeuvre around within the larger tanks and all personnel wear head protection combined with dry suits or buoyancy jackets when working over water.
